Small system challenges: low supply capacity and aging infrastructure has Damar, KS facing improvements

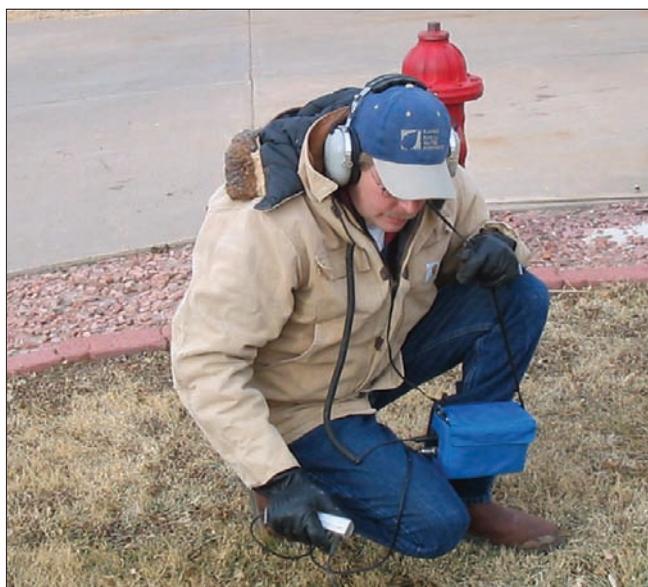
Several different types of leak detection equipment are utilized by KRWA staff. This photo shows KRWA Tech Doug Guenther using a sonic listening device to pinpoint the location of water escaping from a service line.
