# Rural Water Training & Tech Assistance Program For SDWA Compliance

## Small Water System Case Study

**Lakeside Village, Kansas**  
Jefferson County  
Populations Served: 180

### Lakeside Village Improvement District

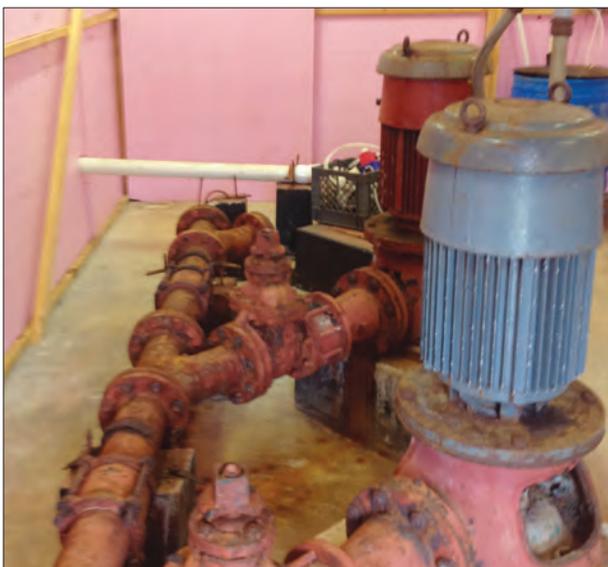
Humid conditions and chlorine gas exposure has caused piping to rust.

would also not start. Boller looked inside the system's pump house and observed several problems. First, the pipes and the electrical panels are rusted due to many of exposure to humid conditions and chlorine gas fumes. Lonnie recommended that the system contract an electrician to figure out why one of the well pumps would not function and also why one of the high service pumps would not work. Lonnie also recommended requesting a cost estimate from the electrician for moving the chemical feed pump to the opposite side of the building. He explained that if the chlorine were moved to the opposite side of the building, it would be contained in a small room and isolated from the rest of the building. The chlorine room could have a separate, outside entrance with an exhaust fan and light switch outside the building. Lonnie also recommended that the rusted pipe be cleaned and painted with an enamel paint, which should be color-coded to indicate raw water pipes and finished water pipes. He also recommended placing a dehumidifier in the pump house to help with the moisture problem when the pipes sweat in the summer. This may also help prevent rusting the electrical controls.

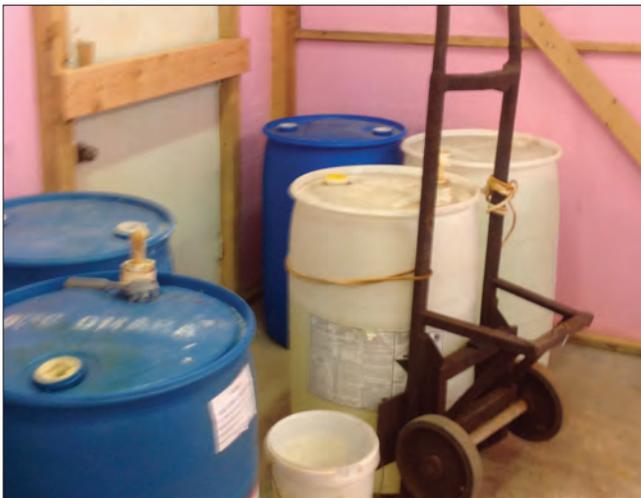
Another problem that he observed was that the system had several months' worth of sodium hypochlorite on hand. Lonnie explained that liquid chlorine solution loses its strength over time. He recommended only keeping one month's supply of chlorine on hand. He assisted Operator Barnes with ordering a new chemical feed pump and tank. He recommended adjusting the system's chlorine dosage at 1.0 mg/L in the winter months and 1.5 mg/L in the summer months to maintain compliance with the state required minimum residual at 0.2 mg/L at every tap.

**The system had several months' worth of sodium hypochlorite on hand.**

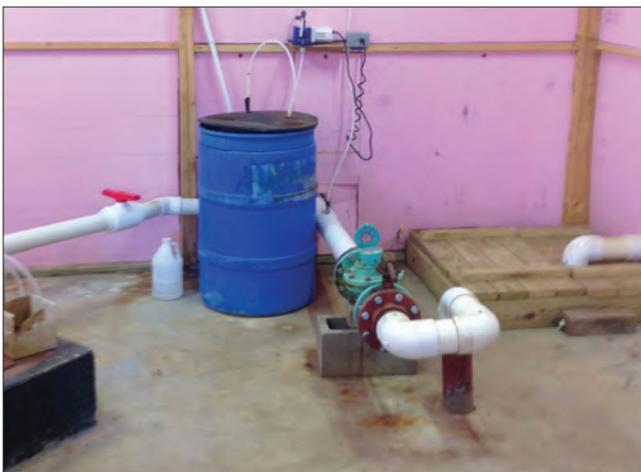
**The system's chemical feed set up.**

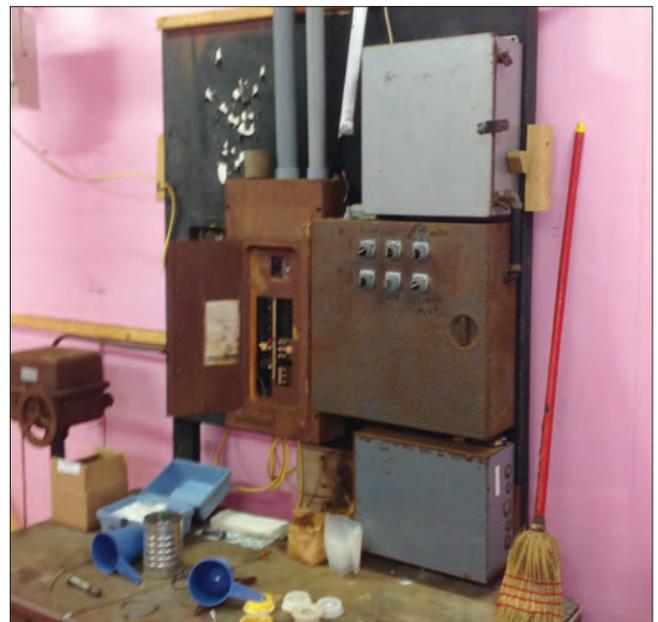
**The electrical panels are rusted after years of exposure to moisture and chlorine gas vapor.**
