KDHE – KRWA Referral Program Addresses Wastewater Effluent Violations at City of Mound Valley

Small Wastewater System Case Study

City of Mound Valley, Kansas

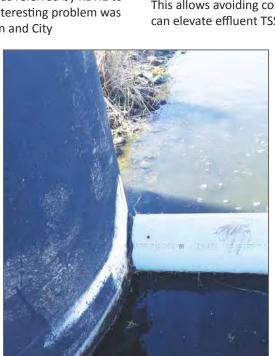
The new pipe extension connects to the existing discharge box. KRWA Tech Jason Solomon and Rex Hess, Superintendent at Mound Valley, made sure the pipe made a watertight seal with the box.

In November 2019, KRWA helped the city modify the effluent box to allow drawing effluent from below the water surface. A 10-foot section of 8-inch PVC plastic pipe was extended horizontally out into the lagoon from the effluent box. A watertight

connection was made where the pipe connects to the existing hole cut into the side of the box. And at the other end, the pipe was extended 20 inches down below the water surface using a 90-degree PVC tee. The pipe extension is supported by a couple of T-posts driven into the pond bottom and clamps.

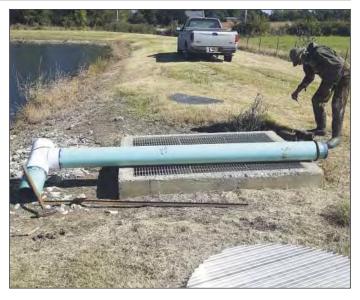
This photo shows the extension before placement in the lagoon. Notice the 90-degree tee and 20-inch downward extension that allows drawing effluent from below the water surface.

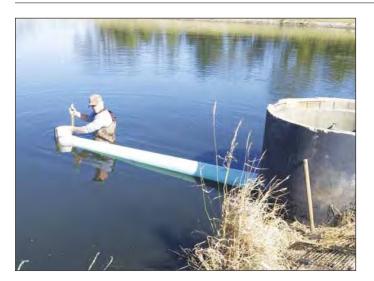
KRWA Tech Jason Solomon installs posts to support the 10-foot pipe extension.

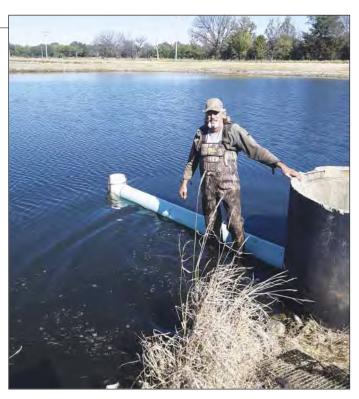
Rex Hess, city of Mound Valley Superintendent, is shown with the new pipe extension in place and operating. Since this improvement was made, the lagoon effluent's quality has improved and now meets limits for TSS and BOD.

Since this modification was made to the effluent box, the lagoon has consistently met BOD limits. It is important to note that effluent TSS has also dropped significantly, especially during the summer months. This has translated to lower effluent BOD results even during summer months when TSS values are usually higher due to algae. For example, Mound Valley's June effluent BOD results for 2017-2019 ranged from 33 to 93 mg/l. The June 2020 effluent BOD result was 5.2 mg/l, which is well below the 30-mg/l limit. It is apparent that drawing effluent from 20 inches below the water surface is providing a better quality effluent all around. While it will take more than one year's worth of data to evaluate the improvements made to the effluent box, the results are very encouraging.

See the attached photos. Depending on water depth, the lagoon is now drawing effluent from at least 20 inches below the water surface.
