# Conducting a Water Plant Filter Profile (Media Evaluation)

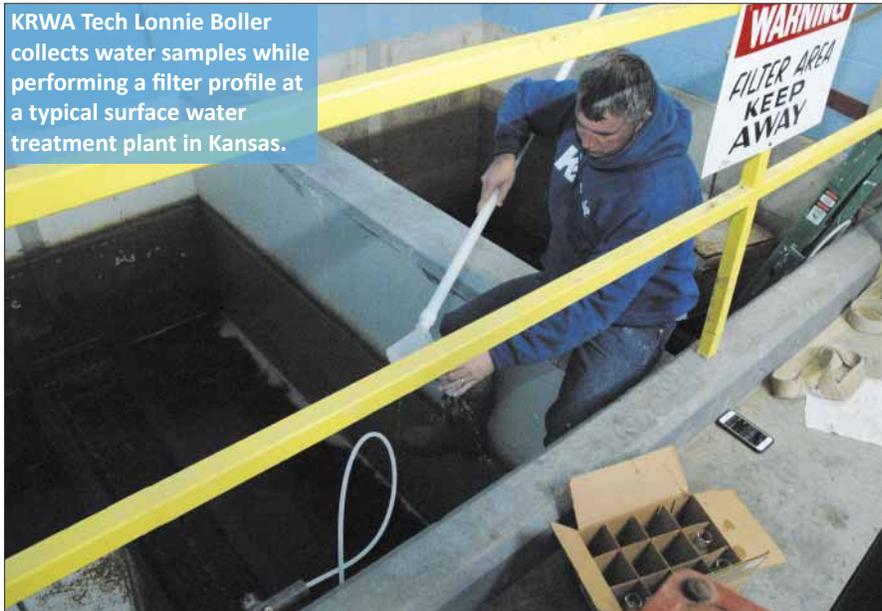
KRWA Tech Lonnie Boller collects water samples while performing a filter profile at a typical surface water treatment plant in Kansas.

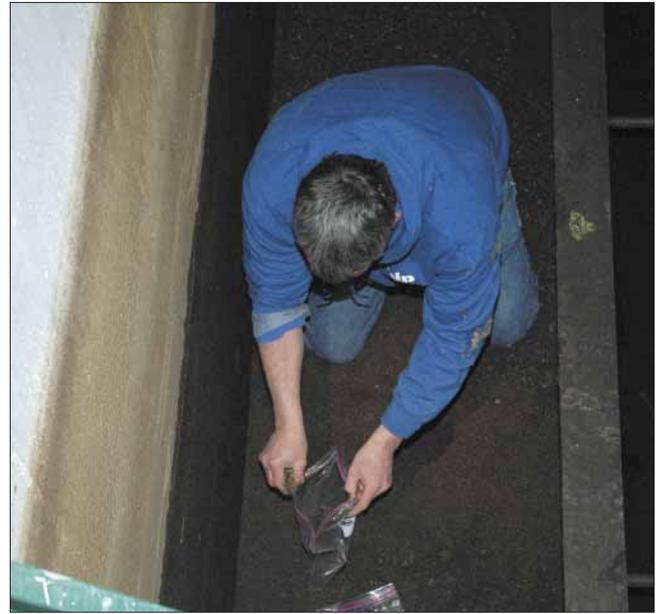
The anthracite media appears to be in good condition. The media in filter No. Two was jagged and sharp, consistent with good media, unlike worn-out media rounded and dull. Many operators believe just because the media's old it should be replaced. There are laboratories that can perform sieve tests and look at the media under a microscope to determine its condition. This particular filter media looks fine based on our observations and the individual filter effluent (IFE) readings during filter runs and the low filtration rates. I would not recommend the replacement of the media in normal instances. Media replacement is a costly project and I would only consider a replacement if laboratory results indicate the need to do so. I would make sure you have all information before deciding on a replacement.

**This photo shows KRWA Tech Lonnie Boller collecting a sample of media to be sent to a laboratory for analysis. For the media to be effective, it needs to be jagged and sharp. Laboratories can perform sieve analysis along with viewing with a microscope to determine its condition.**
