It's a Bird; It's a Plane! No – It's a Drone Searching for a Water line Leak in Kansas

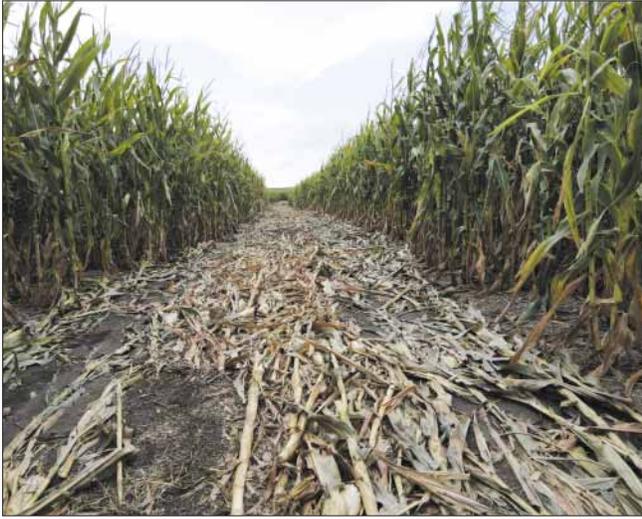
This photo shows the path cut through the cornfield to reach the location of the leak.

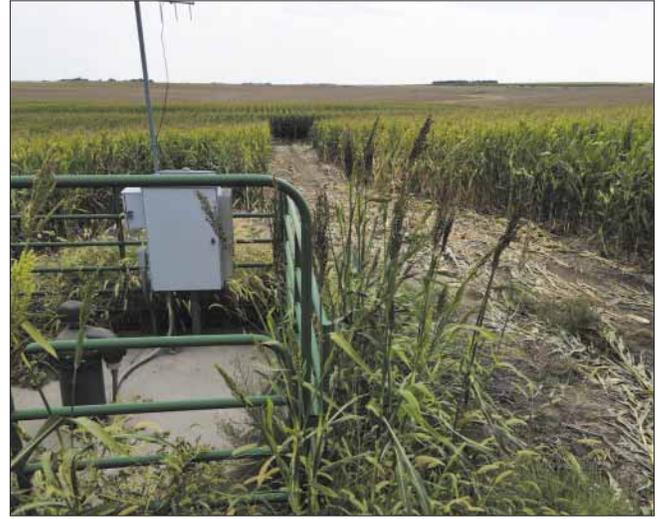
This photo shows the path through the cornfield from the wellsite.

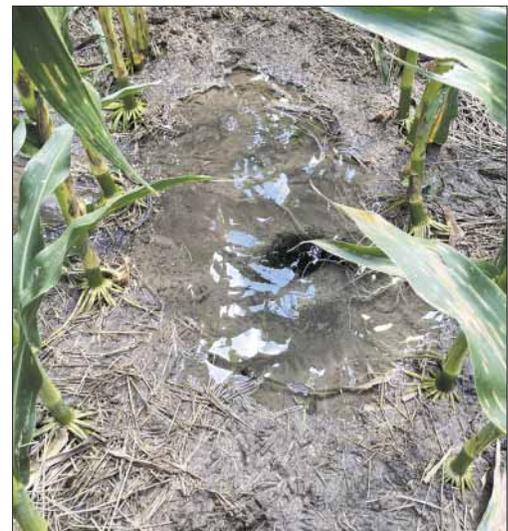
Typically, when there's a high volume leak from a water line, the result is a blow hold such as this found near Kirwin.

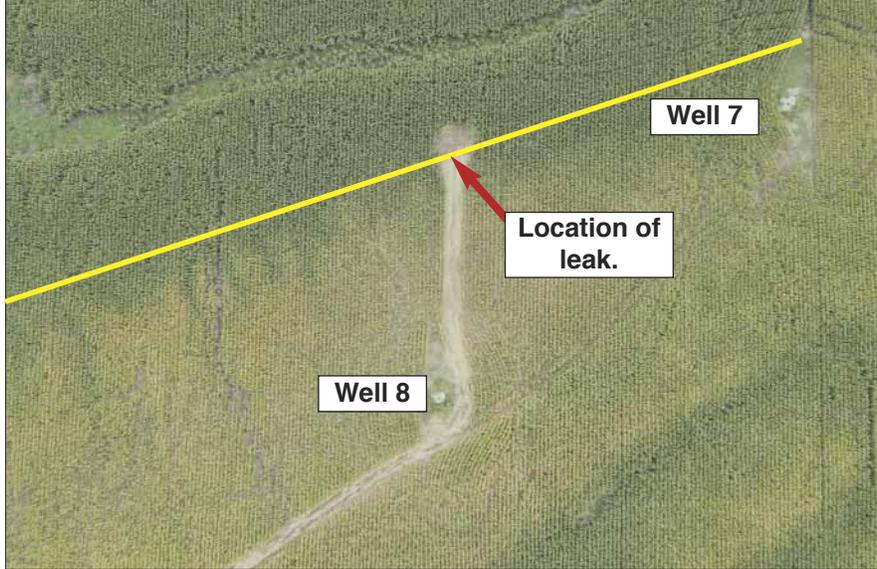
This view from the drone shows the location of the leak and the path through the corn to reach it. The break was at the point where the pipeline from Well 8 connects to other transmission line.

the waterway just south of where Harold said the intersection of the pipelines from each well connect to a single transmission line. I spotted something shiny in an opening in the grassed waterway. I dropped down to 15 feet again and could see clear water running. This location was approximately 150 feet south of the junction of the two pipelines.

walked into the corn field from the south. Harold walked into the field from the east well and then south towards my location. Visibility was about five yards and along with the sun's location, we were able to stay on course to the location where the view from the drone showed clear water at the waterway. We located the leak at the point of the junction of the two well lines. I followed the water about 150 feet to a blow hole that was not visible from the drone.

The leak was repaired the next day. The estimate on the crop damage to the corn was \$700 as a temporary path had to be made to the repair site. If this leak had not been spotted, it would probably not have been discovered until corn harvest in late October.
