## Iron Tuberculation Causes Well Pump Failure

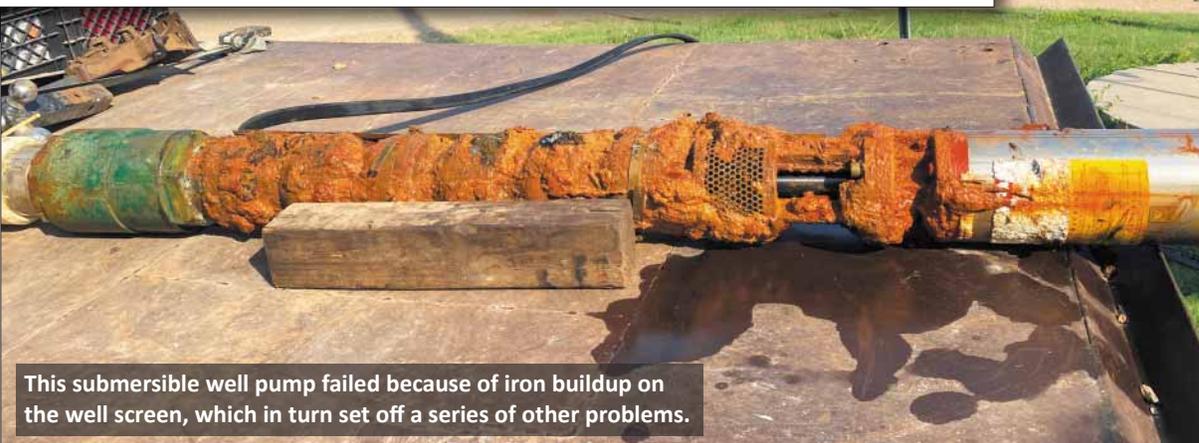
This submersible well pump failed because of iron buildup on the well screen, which in turn set off a series of other problems.

The pump was pulled and inspected and the first problem noted was the motor drive shaft splines were stripped and unable to turn the pump. An insulation breakdown test indicated the motor was near thermal failure and deemed shot. The foot valve or bottom check valve had failed and the spring and valve seat were damaged. Heavy iron tuberculation was deposited throughout the pump and the intake screen was partially blocked. Finally, the pressure transducer was partially blocked by iron deposits and pressure readings were slowed by this limiting the effectiveness of the variable frequency drive to do its job.

With all the problems identified, the pump column pipe would empty and fill with air so, on each pumping cycle, air would compress and cause water hammer. The variable frequency drive was not operating properly because the pressure sensor was limited by a blockage. The pump bowls had iron deposits making the motor work harder.

This pump was installed new in 2011. This unit could likely have provided many more years of service had the well been treated with super chlorination annually. The new pump for this small town will cost \$7,550 plus installation. The well will be acidized and chlorinated before being put back into service. Those costs are not known at the time of this writing.

If money and downtime were not an impediment, I believe the well should be inspected with a camera and if super chlorination does not keep the condition ahead of the iron depositing, then a more aggressive cleaning is needed to prevent total pump failure when the well doesn't have high-quality water.
