Wastewater systems require basic maintenance

Starting with the lagoon

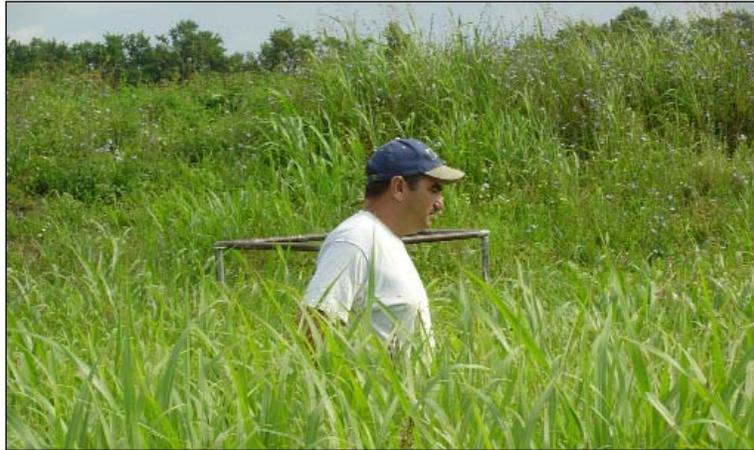
After introductions and background information about the system were exchanged at city hall, our first stop was the wastewater lagoon system. Arriving at the lagoon site, I saw weeds nearly five feet tall (see photo 1.) This isn't the correct way to maintain a lagoon system. All this vegetation will allow vermin to burrow into the cell walls. The burrows can weaken the dikes. The weeds also block

Photo 1. KRWA's Wastewater Tech Charlie Schwindamann stands in some high weeds near a lagoon. (see pipe around influent structure in background). The operation of a lagoon system can be affected when weeds and brush are allowed to get out of control. The tall weeds restrict wind from blowing across the cells. Wind causes ripples that add oxygen and help with the treatment of the waste.

wind, reducing the natural rippling or wave action that adds critical oxygen for the treatment process. That oxygen is essential for proper treatment of wastewater to occur. Wastewater lagoon dikes do not need to be 'house yard perfect' but the grass or weeds need to be mowed before the growth reaches knee high.

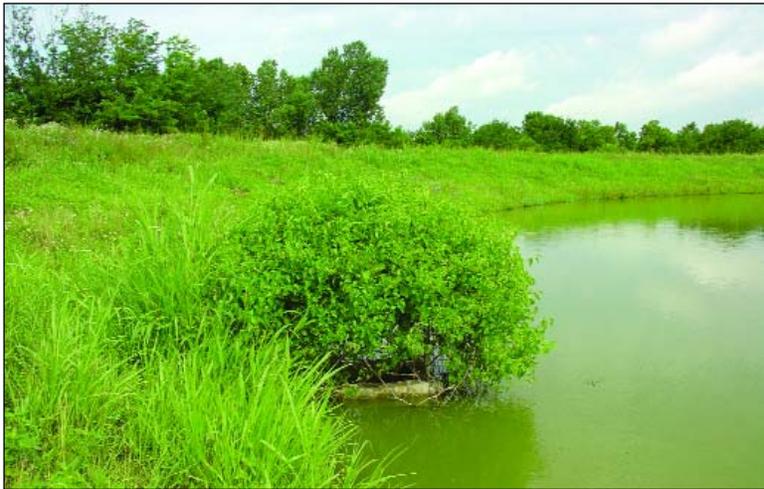
Photo 2. Vegetation around the effluent structure shows that no one has given a careful inspection to the system for quite a while. These bushes had to be pushed back to view the effluent (discharge) structure of the system. This cell was operating at least 18 inches deeper than the discharge gate. With proper operations this situation could be avoided, as it would have been discovered by the operator who should then have taken corrective measures. Operators should check lagoon systems at least three times weekly, including an inspection of each structure. The pipe to the structure could be partially plugged or extreme inflow and infiltration (I&I) may have caused a high water level. This system was discharging a small amount at the time the picture was taken.

Next, we checked the effluent structure. It was covered with vegetation (see *photo 2.*) It appears that no one had inspected the effluent for quite some time. Such inspections should be part of the daily round of duties for a wastewater utility operator. Operators need to walk around the lagoon to check for any problems that may have occurred and then correct the problems. After tugging our way through the vines around the effluent structure, we found that the effluent pipe was partially plugged. Flow was going over the weir. This was evident by the level of the cell being about 18 inches higher than the weir in the effluent structure (see *photo 3.*) The wastewater was within inches of flowing over the top of the effluent structure, directly to discharge.

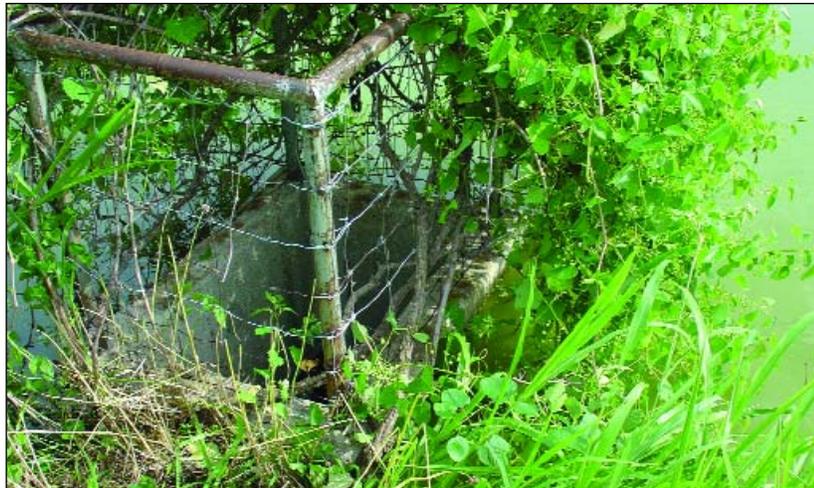
Photo 3. A lagoon system with the depth of the cells operating at over 18 inches is too deep.

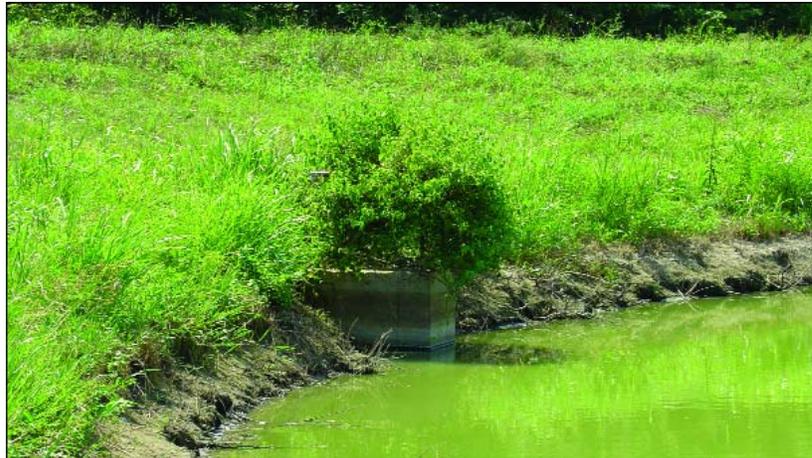
Photo 4. This photo show cells that are operating at the proper depth after the effluent pipe was cleaned. The cleaning allowed the system to operate at the recommended five feet of depth.

I documented these problems to the city while on-site as well as in a follow-up report. The city had a contractor clean the lines. The operating level was lowered to an acceptable level of about five feet (see *photo 4.*)

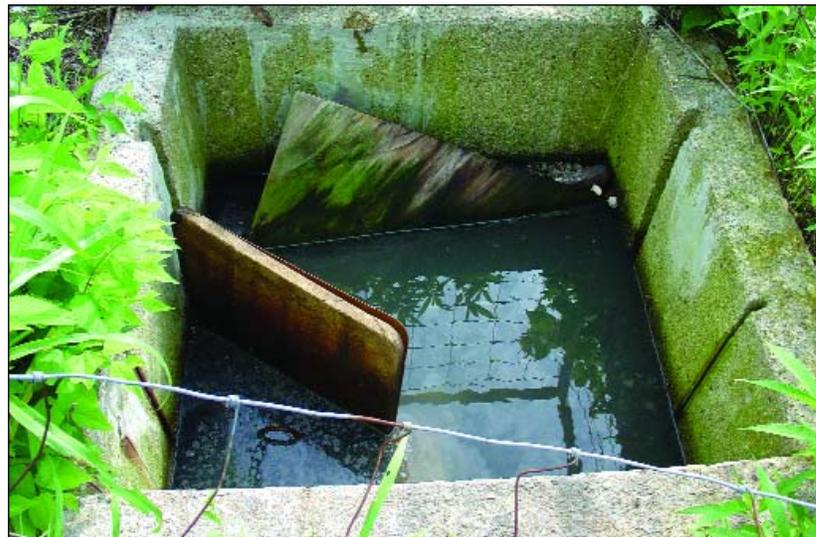
Next, we checked the influent structure. To our surprise, we found pieces of plywood and lumber in it. I believe this material was remnants of some homespun engineering attempt to control the direction of flow in the two-cell system (see *photo 5.*) In a lagoon system, lumber rots and can result in a blockage of the influent pipes which then results in "short-circuiting." A

Photo 5. This is plywood and other lumber in the influent structure of a lagoon system. These pieces can block or possibly plug pipes, resulting in short circuiting where the flow moves directly to the next cell. This lagoon system was short-circuiting as the inlet pipe to the primary cell of the two-cell system was plugged and flow was entering the second (final) cell, then discharging through the effluent structure, likely without the required detention time of 120 days.

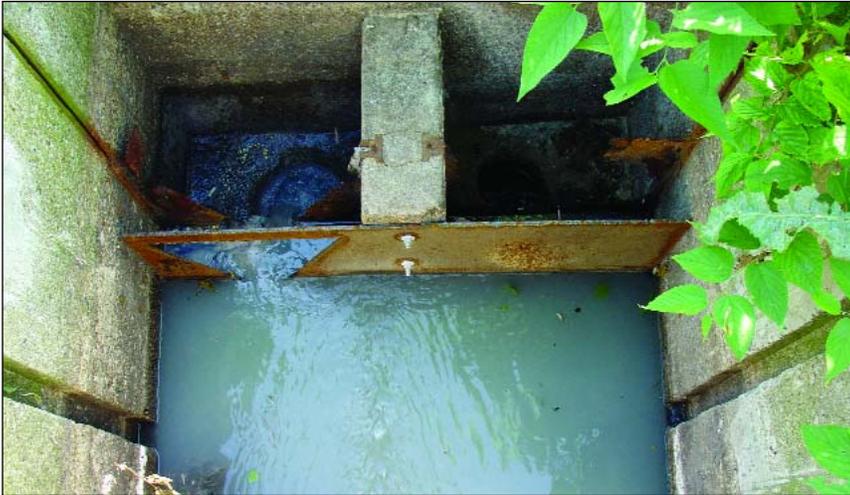
Photo 6. The new "V-notch" wier directs the flow to the right cell, correcting the short-circuiting problem.

city council member who does welding provided a "V-notch" weir to direct the flow to the right cell. That corrected this problem (see *photo 6.*) The weir

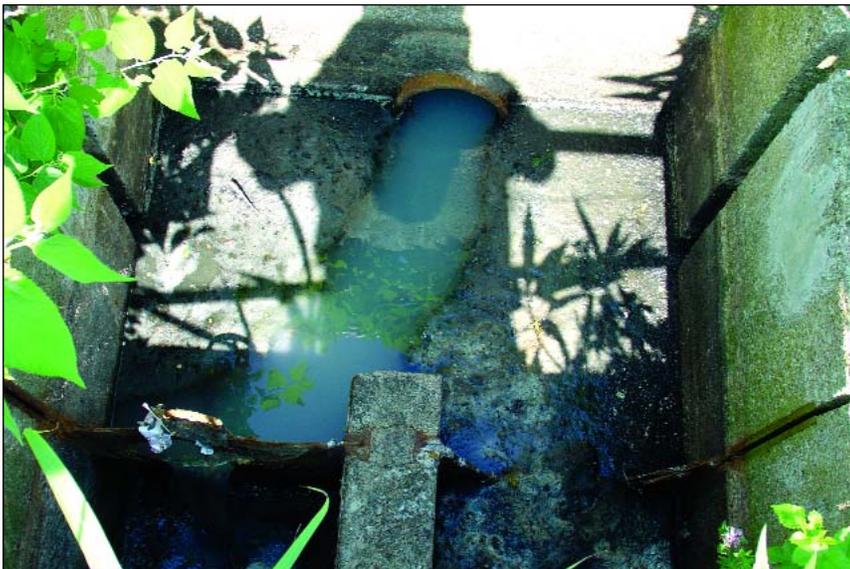
short-circuiting problem on my first visit. During my follow-up to the system several weeks later, I found the influent line to the primary cell was plugged!

The flow was going directly to the discharge cell (*photo 7.*) I helped clean the line the next day. Since then, the system has been operating properly. Short-

circuiting in a lagoon system can cause the utility to fail to meet the discharge permit requirements. That can result in possible fines and increased testing frequency from quarterly to monthly. Additional tests translate to more expense.

Photo 7. The flow is going directly into the final cell. This is commonly known as "short-circuiting". This line was cleaned the day after the problem was discovered; the system is now functioning properly. A local welder who is also a member of that city's council is replacing the rusted gates. This city contacted KRWA for assistance on its wastewater system after the operator quit. KRWA assisted with the lagoon system as well as the water treatment facility.
