# Failure of the Main Valve

## at the Tank Means Big Time Trouble

### **Leaking main valve adds days of labor costs**

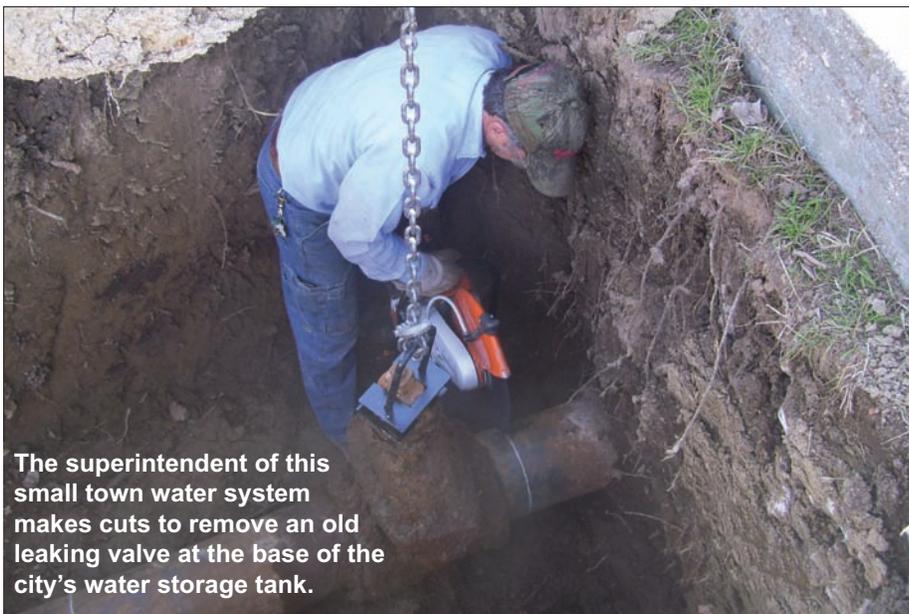
The superintendent of this small town water system makes cuts to remove an old leaking valve at the base of the city's water storage tank.

To complete the repairs, we began by measuring two cut sites, before and after the old valve. We

inserted an 8-inch cast iron stub piece with restrainer glands in the new valve; this would be three to four inches shorter than the planned cut sites on the old valve. The operator had shut the well controls down the day before to drop the tower level to reduce water waste. Two fire hydrants were opened. In about thirty minutes, the tower

was drained. We began cutting out the old valve at about 1:15 p.m. After the cuts were made, the old valve was removed with a backhoe and chain. The new valve was lowered into place after being swabbed with Clorox. Another restrainer gland tied the new valve to the tower side and a High Max coupler tied the stud end to the system side. This required about thirty minutes to complete, after which we began to restore pressure to the system. At 3:00 p.m. I informed the KDHE district office that pressure was almost 30 psi, and rising. By 4:00 p.m. the system was back to normal with most of the air flushed out of the mains.

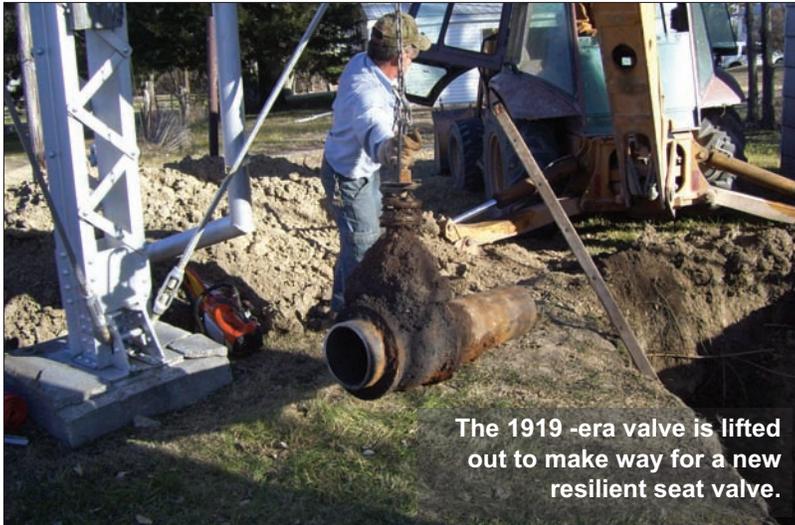
The 1919-era valve is lifted out to make way for a new resilient seat valve.
