Phillipsburg Successfully Pigs Transmission Line

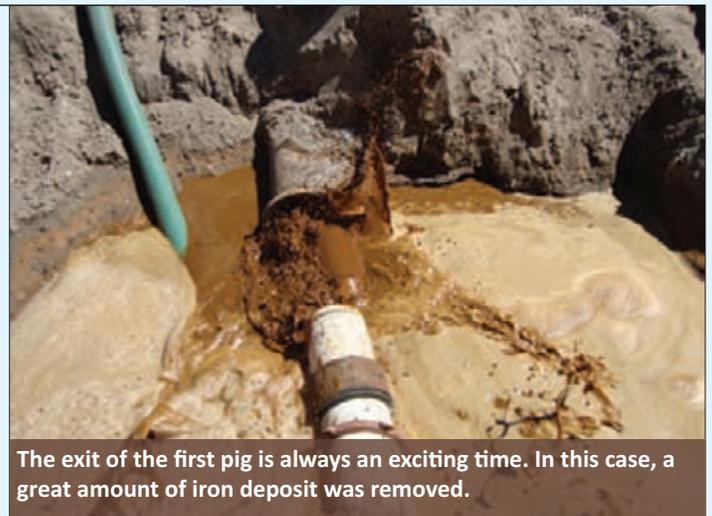
This photo shows the rusty deposit inside a segment of the 8-inch pipeline connecting some of the wells owned by the city of Phillipsburg. Notice the finger marks in the deposit.

We found about 3/8-inch of rusty deposit coating the pipe all around; it was soft and easy to remove by just wiping a finger through it.

I suggested that we start each run with a poly swab. We would monitor the pressure from the well pump and the changes after the pig would exit. The first run was a straight line; it would involve one river crossing with just a little more than one mile of pipeline. After opening the pipe, we found about 3/8-inch of rusty deposit, coating the pipe all around; it was soft and easy to remove by just wiping a finger through it. So we decided to begin with the most aggressive pig that we had; we used a poly bear style pig. The bear was difficult to insert into the pipeline. We removed a three-foot section of pipeline, got the pig inserted and reconnected the line using mechanical joint couplers. Phillipsburg has and maintains a swimming pool, the city has powdered calcium hypochlorite on hand. I suggested we add about a pound per run of each pig to help with the removal of the iron buildup. We ran the poly bear through three times; the greatest amount of material was removed on the first run. With the pumping rate of only thirty to forty gallons per minute, the process took several hours. The highest pressure reached was 80 psi. When the well field was test run no improvement was noted.

As mentioned earlier, there was only 3/8-inch of buildup inside the pipeline, however, I suspect that greater amounts had settled in the low lying areas of the pipeline. The well field is now on line and supplying Phillipsburg with water at an adequate rate.. The pigging project can be conducted again in the future if needed. Even the same pigs can be used as they were not damaged with this first use.

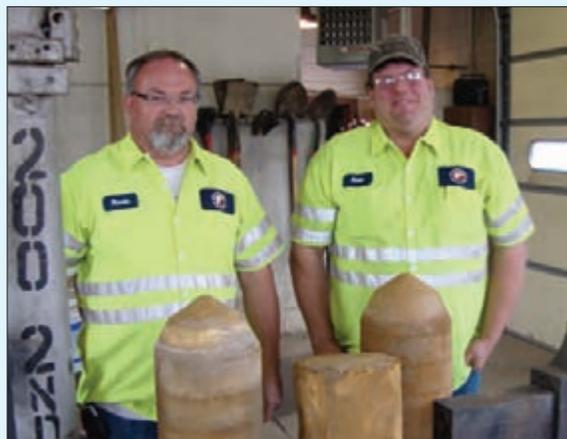
Public Works Foreman Randie Shea and Water Treatment Plant Foreman Kent Footh pose for this photo of the pipeline pigs used to clean transmission lines at the city of Phillipsburg.
