Unique Situation Complicates City of Concordia Water Improvement Project

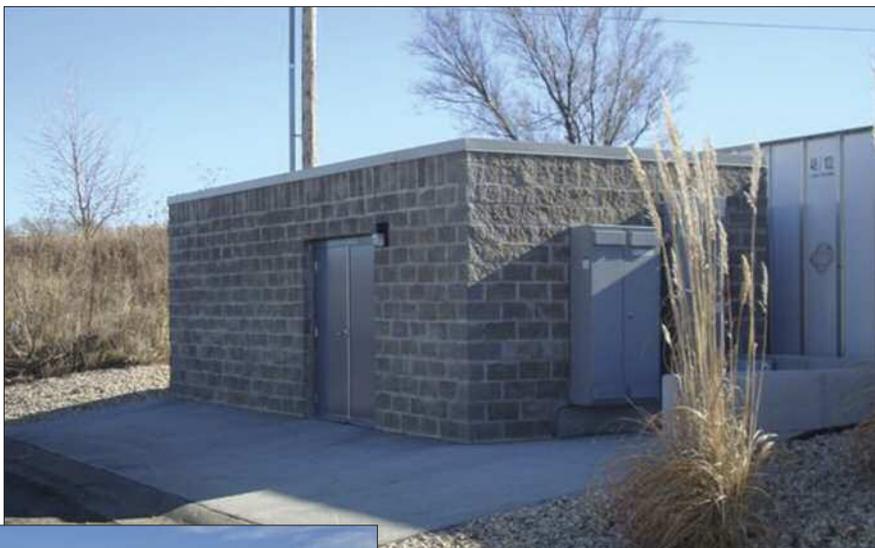
Concordia opted to install a 10-inch fusible PVC pipeline for the extension north of the city. The pipeline crosses the Republican River. A unique feature was the addition of a 4-inch PVC line was also installed as a return to recirculate the water in the system.

Expanding north

Concordia recently completed a line extension north of town for a new development. The north development extension consisted of a 10-inch main line with a 4-inch return line to create a

loop for circulation of the flow. The project also involved installation of a 6-inch forced sewer main, all which had to cross the Republican River. C 900 slip joint gasket PVC pipe was used for the water project. A fusible PVC pipe was used on the river crossing. The fusible PVC is basically C 900 pipe with a different resin to allow for fusion of the pipe. This fused pipe allowed installation without the need of an encasement. The process of fusing PVC is similar to that used for fusing polyethylene (PE) pipe. The new extension will be serving a new 200,000-square foot sales and service center for Concordia Tractor (CTI) and a new state area KDOT office and shop that is planned. Future business growth in that area is also anticipated. The project contractor was J and K Contracting, Junction City, KS.

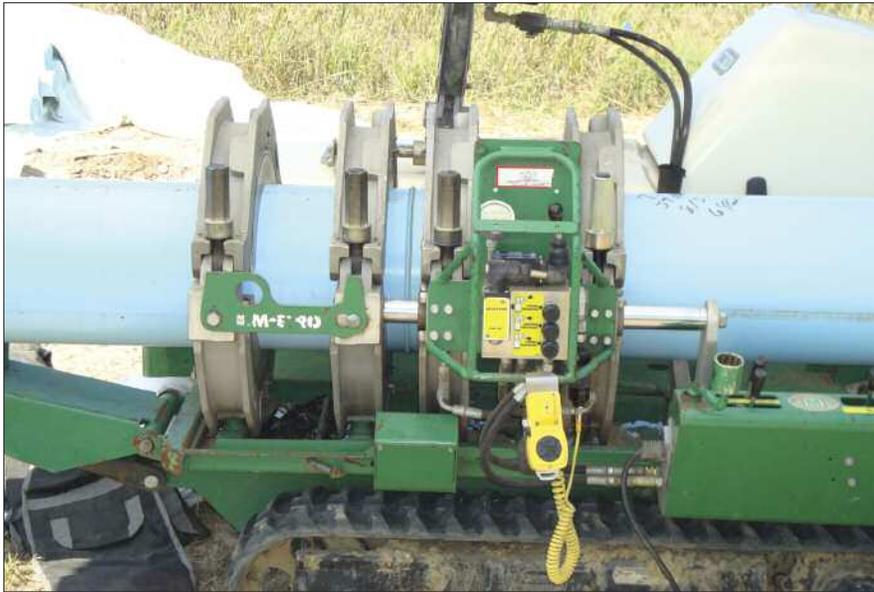
The contractor on the project, J and K Contracting, Junction City, KS, fused the new pipe using this McElroy Tractstar fusion machine.
