Pigging Raw Water Line Helps Improve Water Quality

Recently the Kansas Rural Water Association (KRWA) received a call from Harold Hunzeker, operator for Nemaha Rural Water District No. 1, requesting assistance in cleaning the raw water line from one of the district's wells.

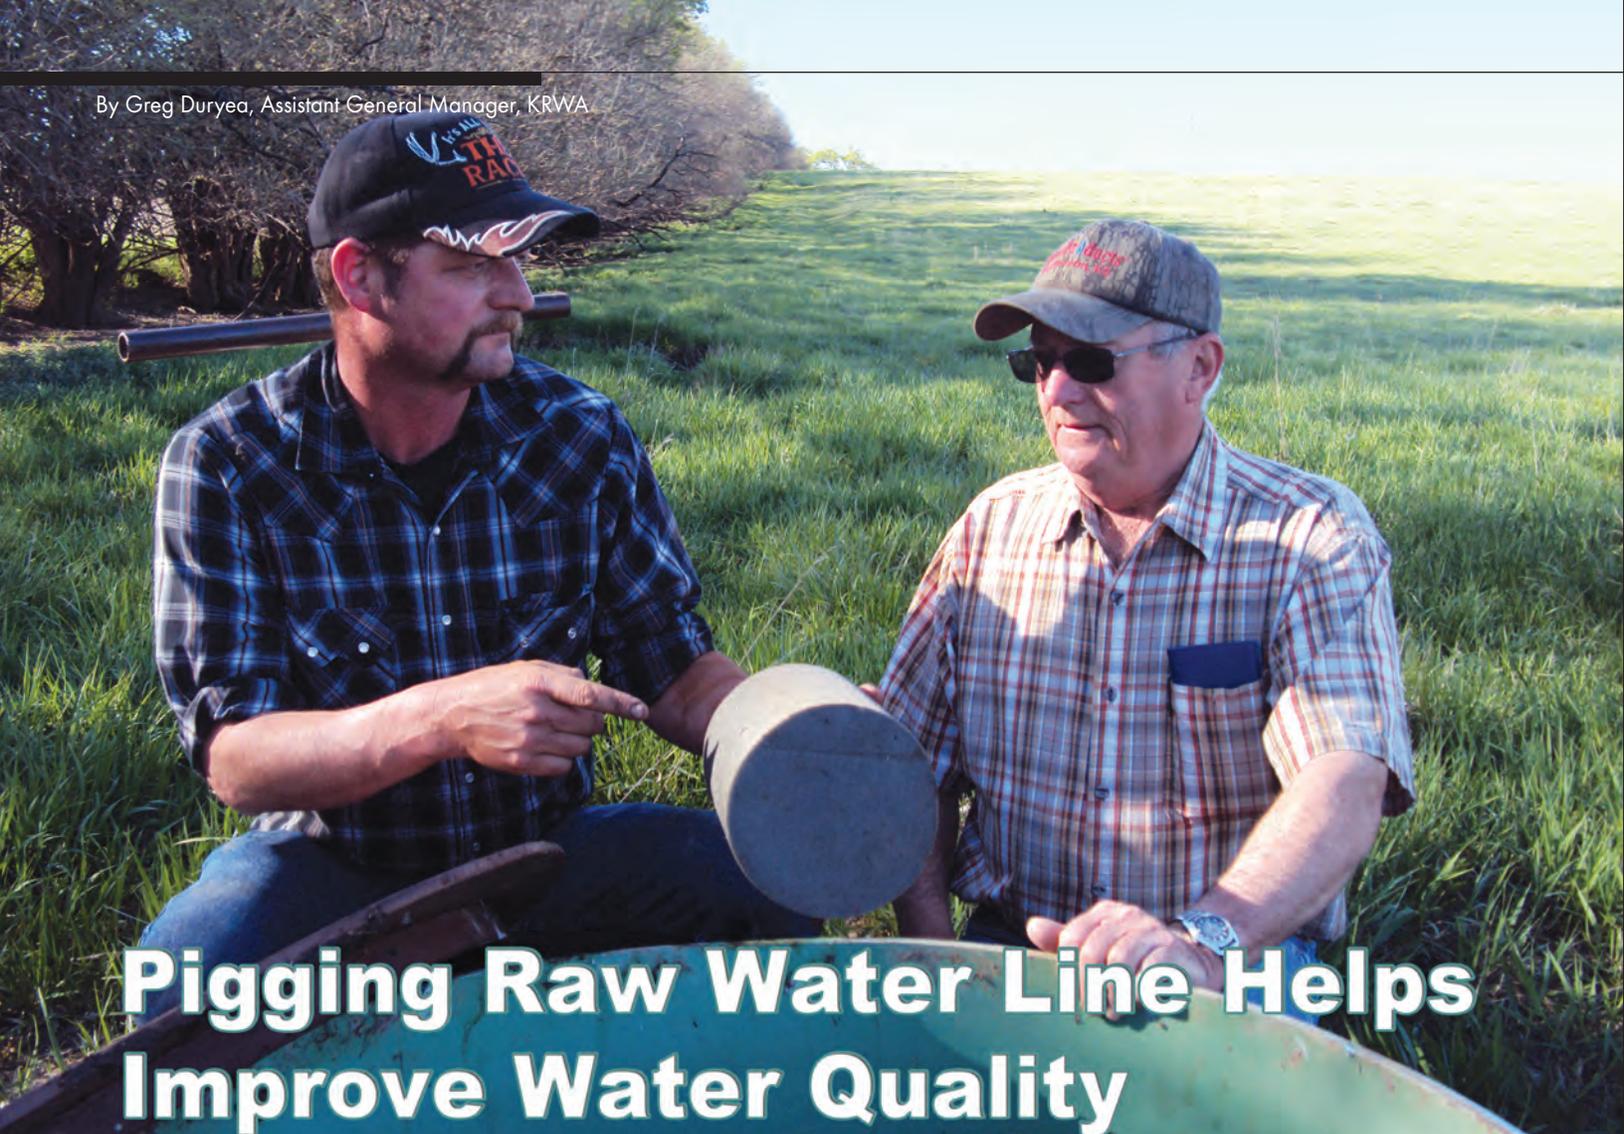
KRWA Tech Tony Kimmi explains the pigging process to Harold Hunzeker, operator at Nemaha RWD 1. The district operates six wells. They produce water at rates of 26 to 80 gallons per minute.

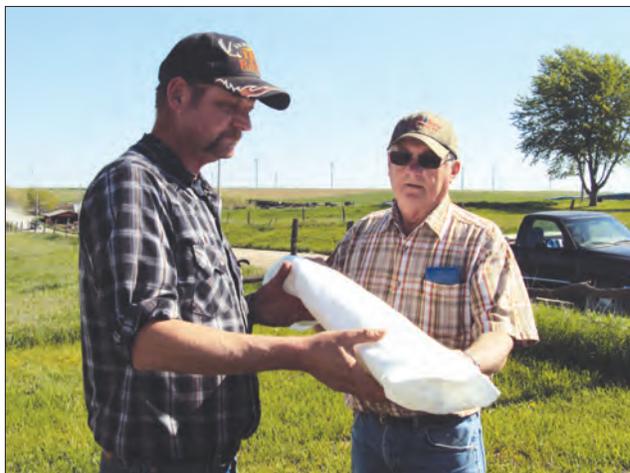
Nemaha RWD 1 operator Harold Hunzeker shows KRWA Tech Tony Kimmi one of the new filters that is used each time the filters need to be replaced. Three filters cost approximately \$100.

The district has a pressurized filtration system to remove sediment. The unit holds three (3) filters which are ten (10) micron Strain Rite filters. The district purchases the filters from ProWest Filtration. The cost is \$100 each time all three filters are changed.

These filters should last from one to six months before it is necessary to change them. Two of the district's wells pump a very fine sand; the water is high in iron and manganese. A pressure gauge at the district's booster station shows the head pressure when the wells are operating. When the pressure reaches a certain level, that indicates plugging of the bag filter systems. Operator Hunzeker then replaces the filters and the head pressure decreases. Recently, the run time between filter replacement became shorter and shorter. Filters were needing to be replaced every seven or eight days.

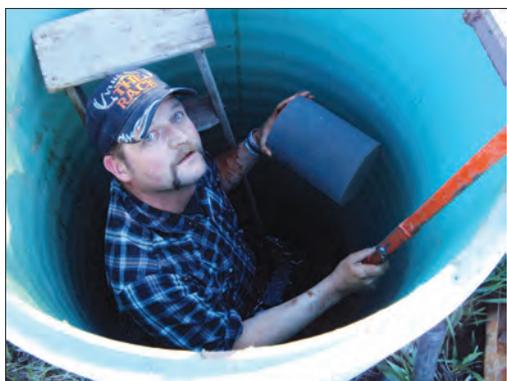
Tony Kimmi prepares to insert the pig in the gated-wye that the district installed years ago in anticipation of additional pigging projects.

When pigging a water line it is usually necessary to excavate the line at the point where the pigs will be inserted. It is also usually necessary to excavate at a point where the pigs will be removed from the line. In the case of Nemaha RWD 1 the district had installed a gated-wye close to the wells where the pigs would be inserted and another wye where the pigs would be removed. The access and egress points

were installed on a prior pigging project. In anticipation of possible future pigging, the installations were made permanent.

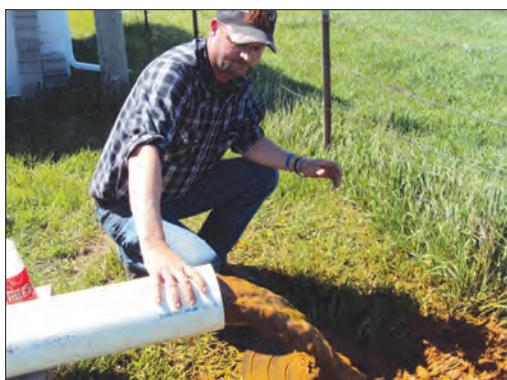
The photo at left shows the slurry of discolored water containing a high level of iron and manganese deposits and fine sand being flushed from the pipeline. Operator Hunzeker reports also that he replaced the

Cleaning the 2.5 miles of 6-inch PVC pipeline removed a lot of sediment from the interior of the line. Most of the sediment was a very fine sand and the color of the discharge indicates that iron and manganese are also in the water.

filters when the cleaning of the line was completed. A month later the filters still do not need to be replaced. It is not unreasonable for the filters to remain in place for two or more months.

Cleaning of the line has saved the district the expense of replacing the filters every week. For each month the district does not have to change the filters \$400 in savings is realized. The only cost to clean the lines was the cost of electricity to pump the water and the cost of the foam pigs. KRWA provided assistance on this service as a benefit of the funding through the Clean Drinking Water Fee, through a contract administered by the Kansas Water Office.
