Troubleshooting a Sewer Force Main Problem at Concordia, Kansas

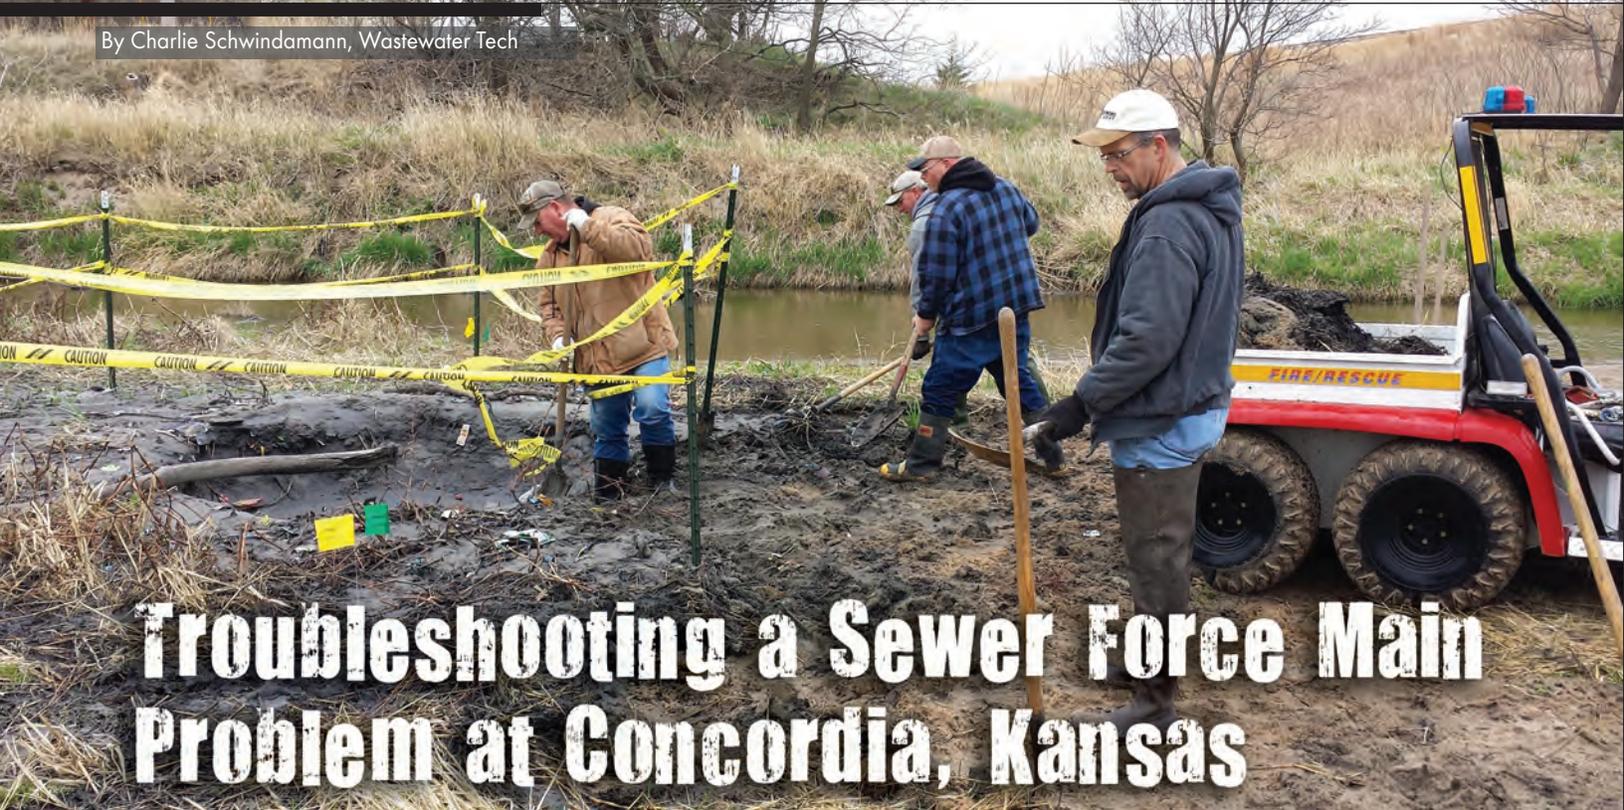
City of Concordia workers load debris from broken force main on a sand bar in middle of the Republican River. Two dump truck loads were removed from the sand bar.

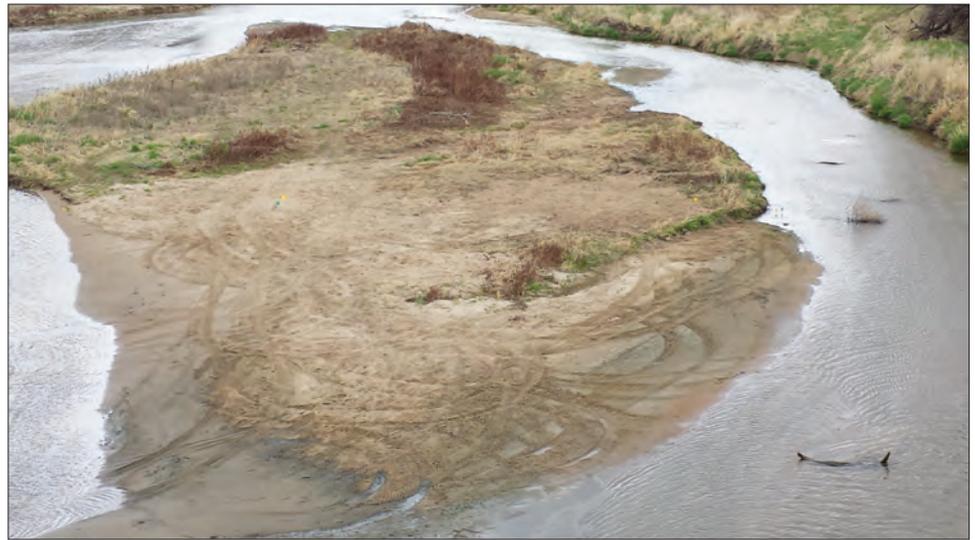
This photo shows the sandbar following clean up by the city.

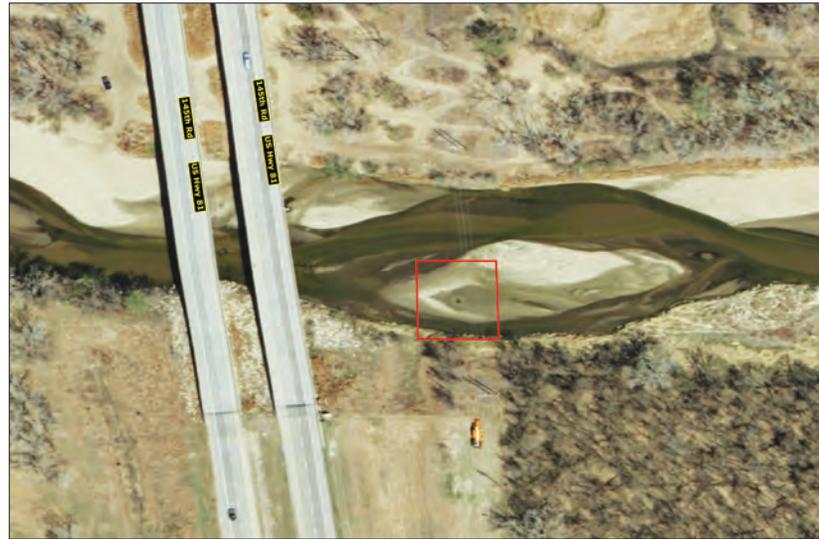
construction company had bored a 6-inch gas main under the river. Was it possible that the installation of the gas line hit the sewer force main?

This is an aerial photo taken in the spring of 2014 that captured the 6-foot diameter hole above the force main near Concordia.

workers connected the water supply to the force main and pressurized it to 80 PSI. They had calculated the amount of water needed to fill the force main at 12,000 gallons. They waited at the manhole where the force main discharged into. Nothing appeared. So it was obvious that there was a leak in the force main. Their worst nightmare was becoming apparent; the force main was broken under the Republican River. Sure enough, water that was pressurizing the force main boiled up to the surface on a sandbar. The city crew immediately shut off the water and contacted the Kansas Department of Health and Environment to make the agency aware of the situation. They cleaned up debris from the sand bar, which took the use of manual labor, an all-terrain vehicle and filled two large dump truck loads. They also took samples from the river at several locations and found no significant increase in BOD or E. coli. They hired a contractor to replace the force main under the river and within a couple weeks the new line was in place and operational.
