Small Wastewater System Case Study

City of Alma

Wastewater System Operations Maintenance and Treatment

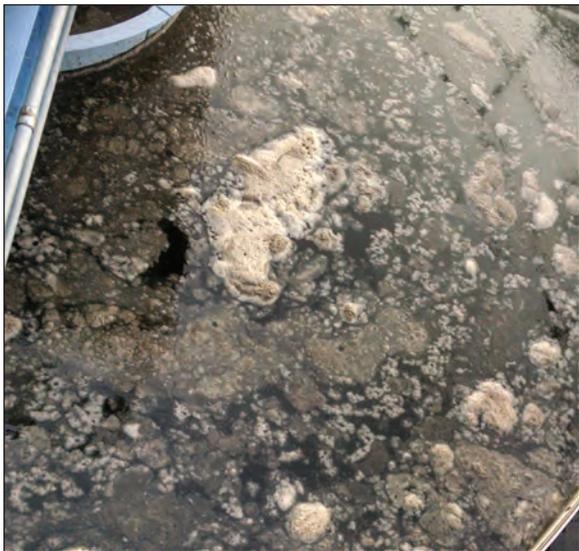
Surface of the plant’s final clarifier. Excessive scum and floating solids have accumulated due to too many solids in mixed liquor of aeration basin.

On the day of the on-site visit, Lamfers met with Alma WWTP operators Jeff Clark and Trent Viergever. Lamfers observed several problems with the plant’s operation. First, the aeration basin was covered with a significant amount of heavy, dark foam. Mixed liquor in the aeration basin was nearly black in color and appeared to be extremely thick. There were excess solids on the surface of the clarifier. Clark mentioned the clarifier had a sludge blanket depth of 1.0 to 1.5 feet. Fortunately, the plant discharges to a four-cell lagoon and permit limits only apply to the lagoon effluent. Regardless, there were several changes that could be made to improve operation of the activated sludge plant so the lagoon is not adversely affected.

First, Lamfers suggested that Clark and Vieregger increase the sludge wasting rate. They ran a 30-minute settleability test and found way too much, dark brown (almost black) sludge. Fortunately the supernatant was very clear. They also observed some scum and solids on the surface, possibly due to grease. They increased the sludge wasting rate from 1,350 gallons/day (225 gallons every four (4) hours) to 1,600 gallons/day (200 gallons every three (3) hours). This represents an 18 percent increase.

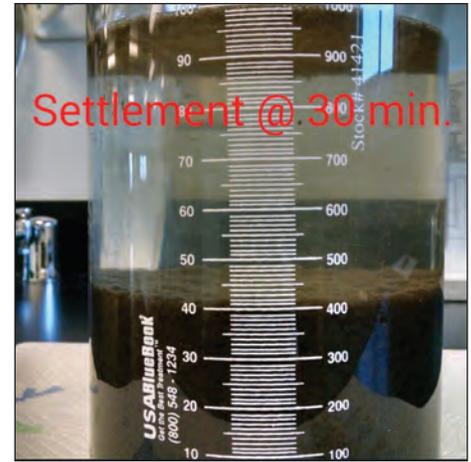
Example of well-settling sludge with proper sludge age while running 30-minute settleability test. Note color and consistency of solids and clear supernatant. Such test results should ensure a high-quality plant effluent.

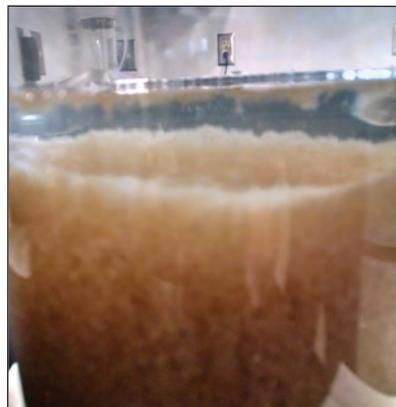
Example of young sludge that settles poorly. It is typically lighter in color and fluffy. Sludge age can be increased by gradually lowering rate of sludge wasting.

Next, Lamfers instructed Clark and Vieregger to monitor the sludge level closely by running settleability tests at least two or three times per week to determine if the sludge level was lowering in the aerated basin. Lamfers was particularly interested in how quickly the sludge would settle in the first ten minutes. Lamfers also recommend that Clark and Vieregger run diluted sludge samples to confirm if there was too much old sludge. Lamfers instructed them to set up three beakers: one with 100 percent mixed liquor; one with 50 percent mixed liquor and 50 percent effluent; and, another with 25 percent mixed liquor and 75 percent effluent. Lamfers stated that if the two diluted samples settle much faster than the 100 percent mixed liquor sample (especially the first ten minutes), then there is too much old sludge. The sludge was likely of high quality, just too much of it and too old a sludge age. So that would confirm an increase in wasting would be warranted. If all three samples would settle at about the same rate, then this would indicate that the sludge that was too young. Lamfers requested that Clark and Vieregger follow up with test results in a few weeks.
