Some Experiences

in Leak Detection

in Towns and RWDs in Kansas

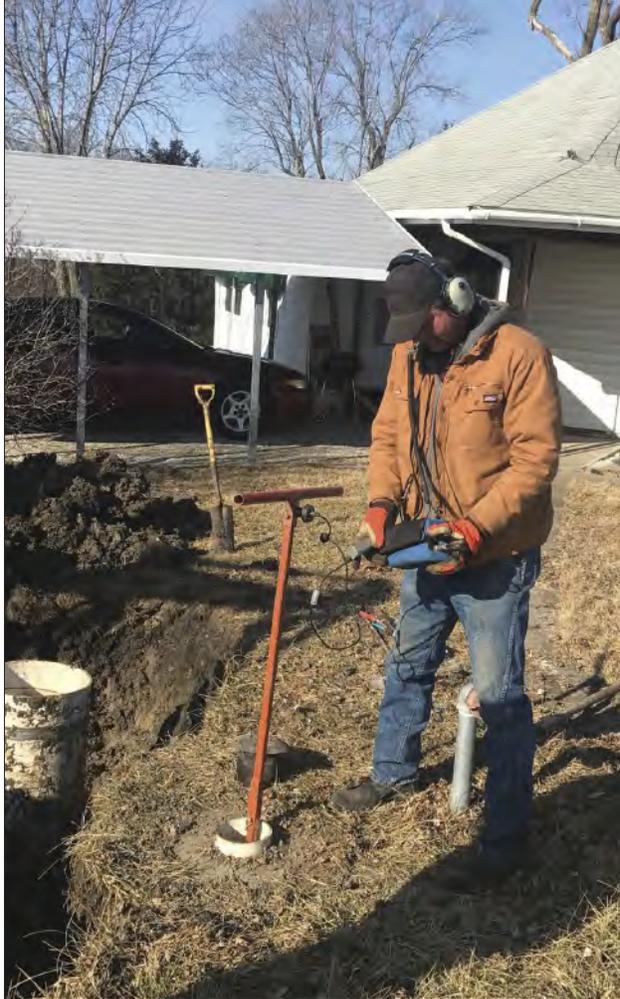
KRWA Tech Tony Kimmi uses sonic leak detection equipment to try to further isolate possible leak on service line to this customer.
