Wastewater System Referrals from KDHE Keep KRWA More than Busy

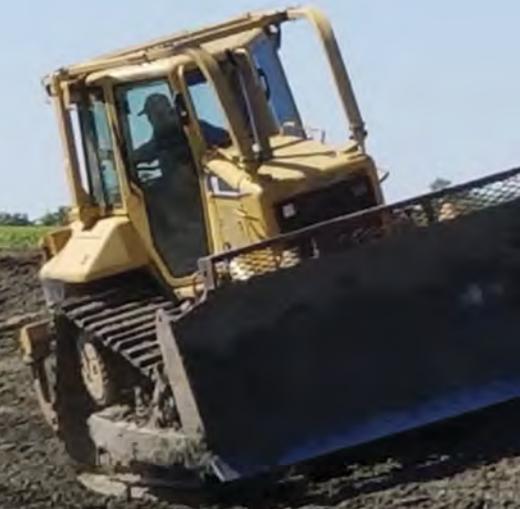
The lagoon was repaired by the city; sludge was removed and the dikes were repaired and reshaped to like new.

complete the work. The city said they would hire local dirt contractor for most of the work and the city would do what it could to reduce cost. Bids were received for the repairs; it was determined that the city could afford to remove sludge and repair one dike per year. The first year went very smoothly; sludge was removed from Cell No. 3 and the erosion was repaired and rock rip rap for erosion control was added.

That city has now completed repairs to two of the three cells; they hope to finish the last cell late in 2018. Only two cells are now being used and there has been no discharge for almost a year. This system is in an area that has been receiving rain through most of the summer. I believe when this project is completed, the system may very well be able to obtain a non-discharging permit.

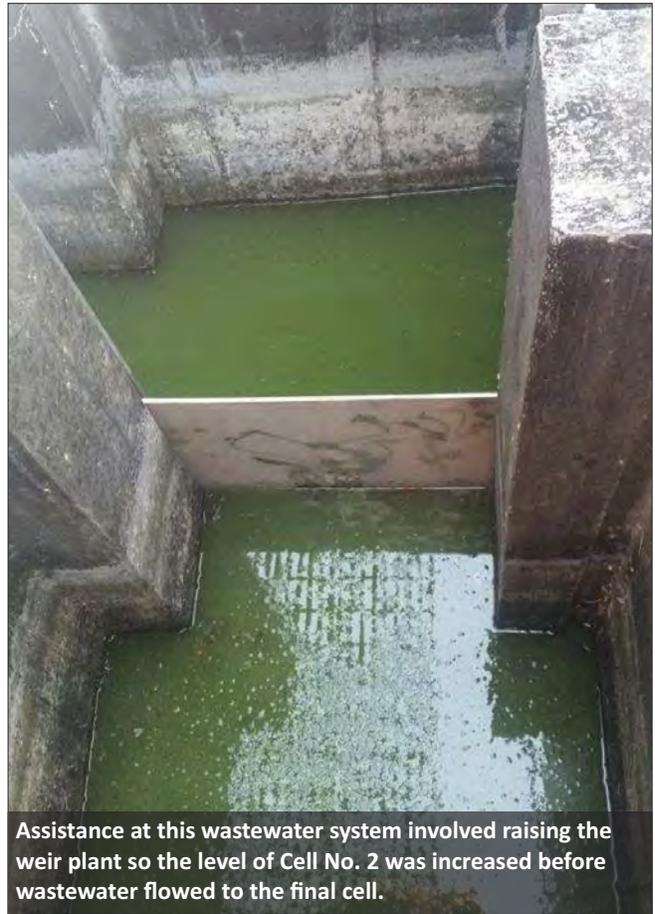
Recently a wastewater operator called me for assistance due to failure of the system's permit limits. I visited the system and found they were short-circuiting due to no weir plate between two cells. There was also discharge from the upper discharge pipe of the cell. The discharge pipe and the effluent pipe in the structure were at the same level. A week after the system operator called, KDHE also issued the referral. The system operator had already made the corrections KRWA suggested; the system is now waiting for a few discharge reports to ensure the corrections are working.

Assistance at this wastewater system involved raising the weir plant so the level of Cell No. 2 was increased before wastewater flowed to the final cell.

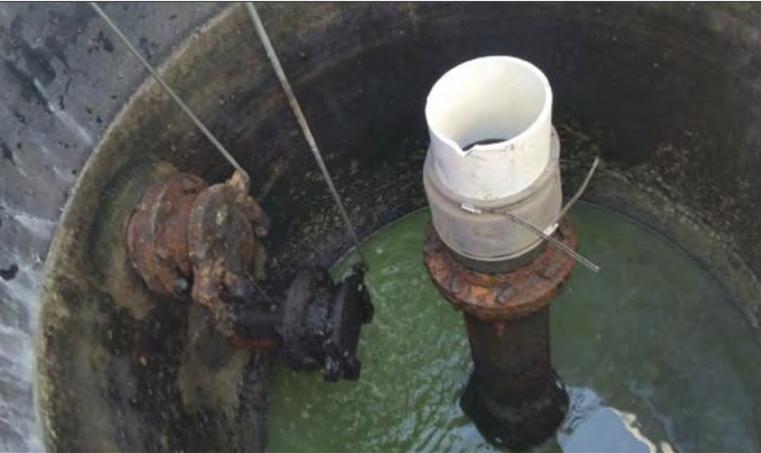
The lower discharge pipe is now being used and a short extension to ensure five feet of operating depth.

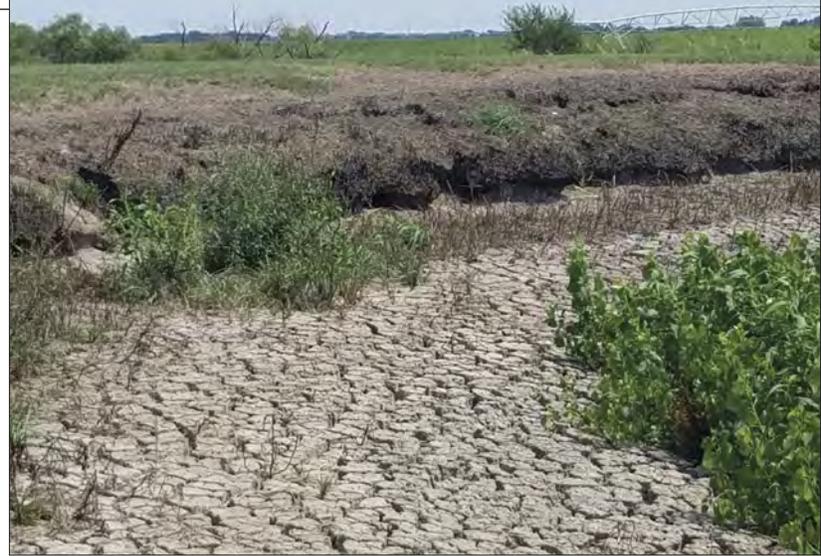
Another example where technical assistance was beneficial was where the community had severe dike erosion and sludge accumulation. The system was referred for failed permit limits. Upon contact with the operator, it was decided to check the sludge to determine the depth of the sludge in the cells. A sludge profile was completed on the first two cells and as it started to storm with lightning, the operator and I decided not to check the sludge in Cell No. 3. While performing the sludge profile severe dike erosion was noted. This was pointed out in a report to the system

Severe dike erosion was noted when performing the sludge profile. After the cell was drained the erosion was more noticeable as shown in this photo.

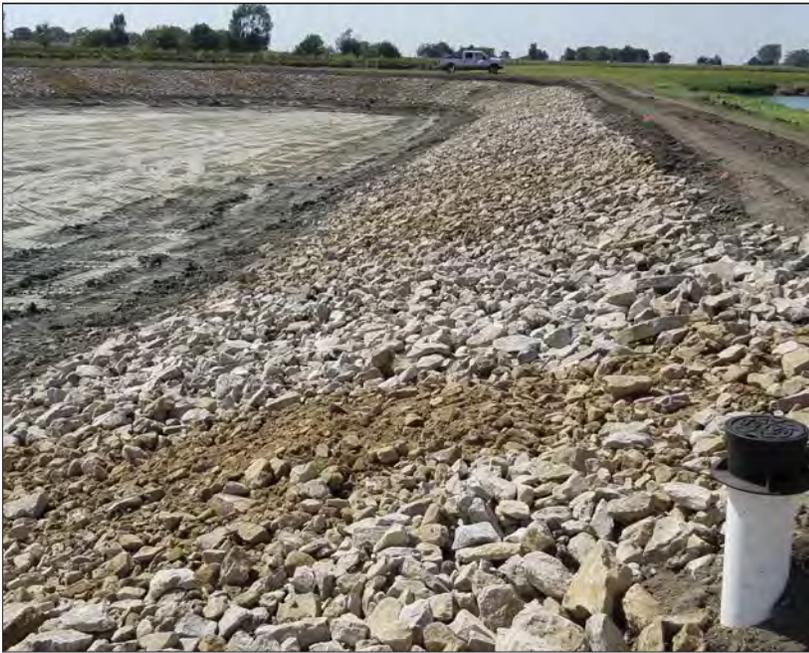
This photo shows the a second of lagoon dike that was repaired and after rip rap was added.
