Operating and Maintaining Water and Wastewater Utilities Becoming More Unaffordable in Small Communities

Case Study: Toronto, Kansas

12-Inch clay tile broken sewer main

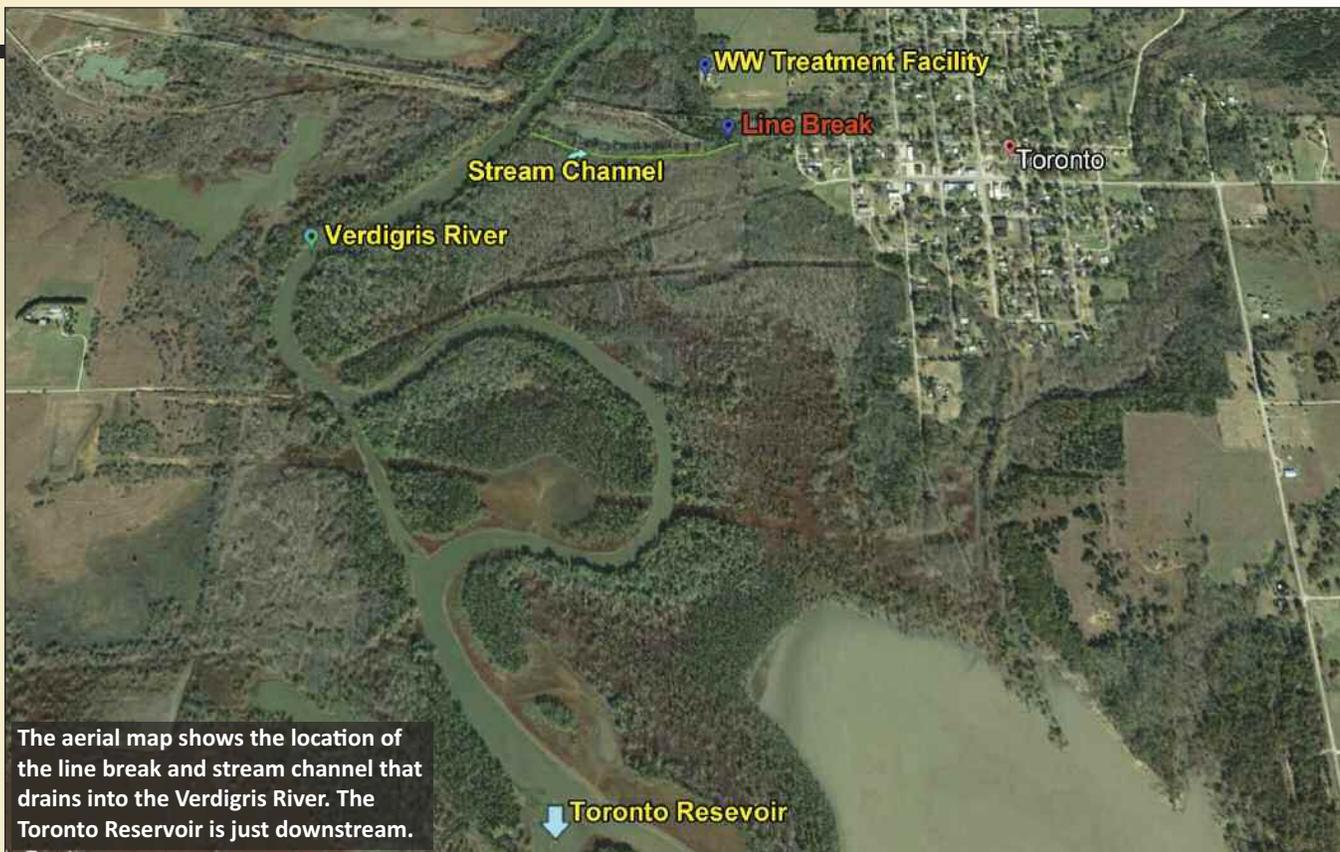
The aerial map shows the location of the line break and stream channel that drains into the Verdigris River. The Toronto Reservoir is just downstream.

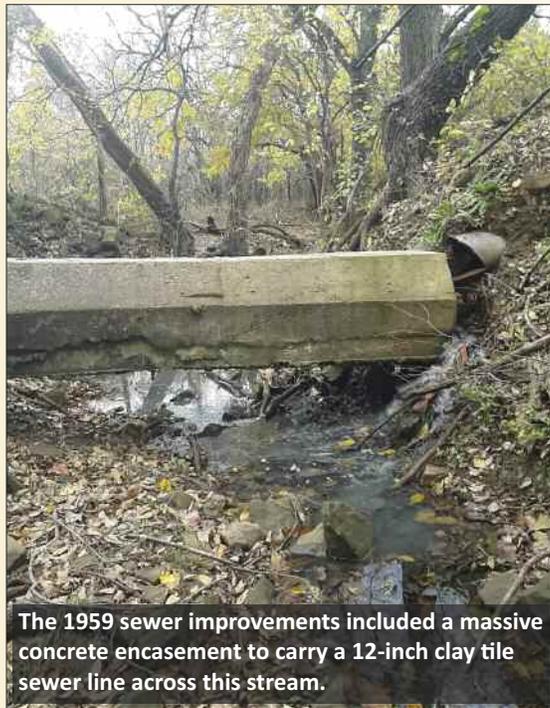
The line break was on the main influent line from town that leads to the wastewater treatment facility. About 600 feet from the line reaching the plant it crosses an unnamed stream channel. At this channel crossing the 12-inch clay tile line was an aerial crossing which means it was suspended above the stream channel bottom. To protect the clay tile line the line was encased in several feet of concrete. The length of the concrete casing was 24 feet in length and greater than three feet in circumference. The casing was built to last to say the least. I have not calculated the weight of the concrete casing and pipe; the concrete cased line was massive.

The 1959 sewer improvements included a massive concrete encasement to carry a 12-inch clay tile sewer line across this stream.

The construction plans from 1959 for a wastewater improvement project were located after the temporary repair was completed. The plans show that the only support for this structure was crushed rock on either end. The creek bank was part of the support system for the structure. Steam bank erosion removed this support over time and the weight of the concrete broke the line. Despite the lack of support the structure was functional for more than 50 years.

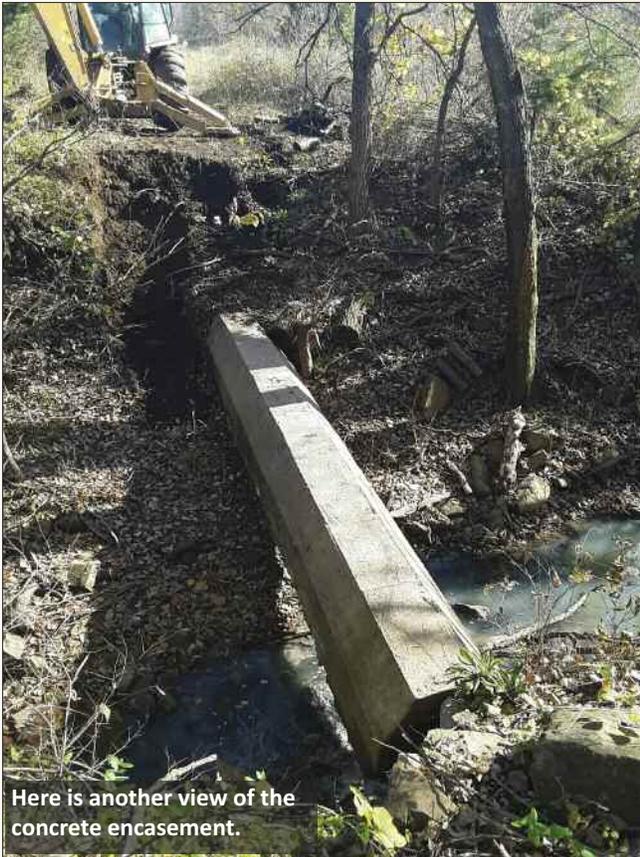
Here is another view of the concrete encasement.

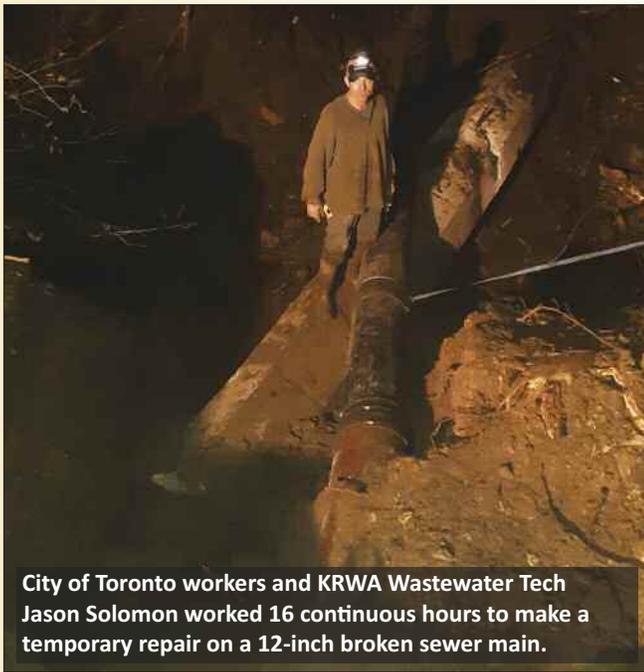
City of Toronto workers and KRWA Wastewater Tech Jason Solomon worked 16 continuous hours to make a temporary repair on a 12-inch broken sewer main.

The major issue was removing or getting the concrete-encased pipe out of the way to install a temporary pipe. The city backhoe could not lift the concrete due to its weight. I was under the assumption a piece of equipment was on the way. Once Troy confirmed that no other equipment was on its way, we began to figure out how to move the concrete encased pipe out of the way. Trenches were dug on either side of the concrete casing and it was then pushed, pulled, rolled, and nudged into falling out of the way. We finally installed the temporary piping; the wastewater discharge was stopped.

At 4 a.m. and 16 hours after beginning work on the project, the temporary repair line was installed. We reinforced the earthen dam and headed home. I made it home and let my dogs out to run and then went to bed. I woke up to a phone call later the same morning still tired

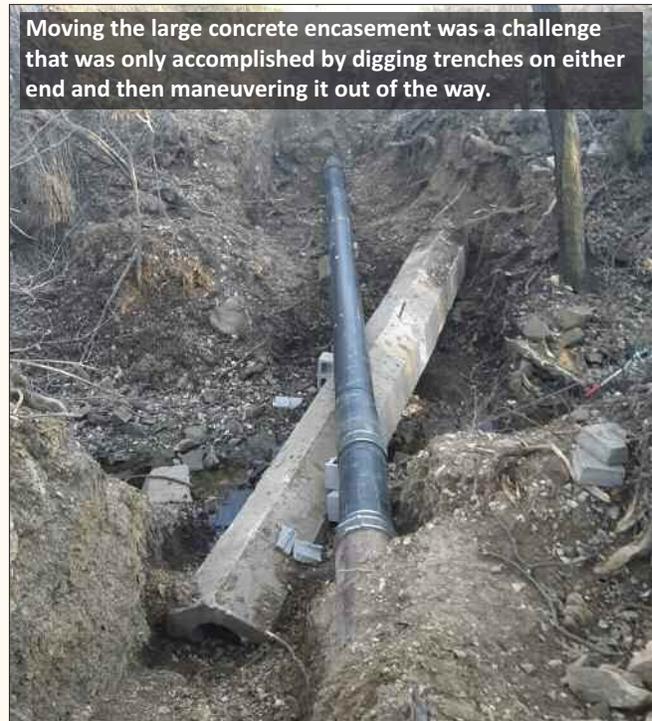
Moving the large concrete encasement was a challenge that was only accomplished by digging trenches on either end and then maneuvering it out of the way.
