# KDHE – KRWA Referral Program Addresses Wastewater Effluent Violations at City of Leocompton

## Small Wastewater System Case Study

### City of Leocompton, Kansas

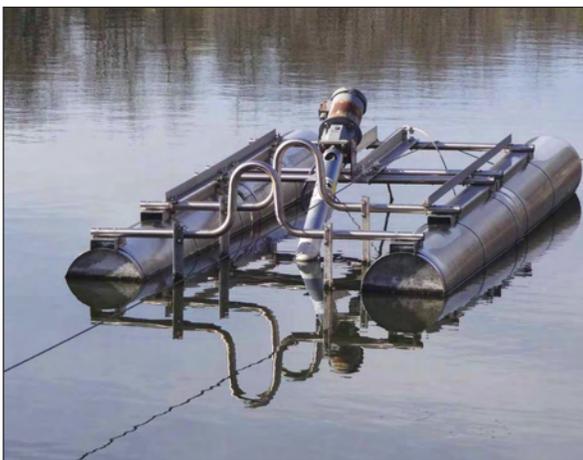
This photo shows one of the three, two-horsepower aerators on Cell 2 of the city of Leocompton’s wastewater lagoon.

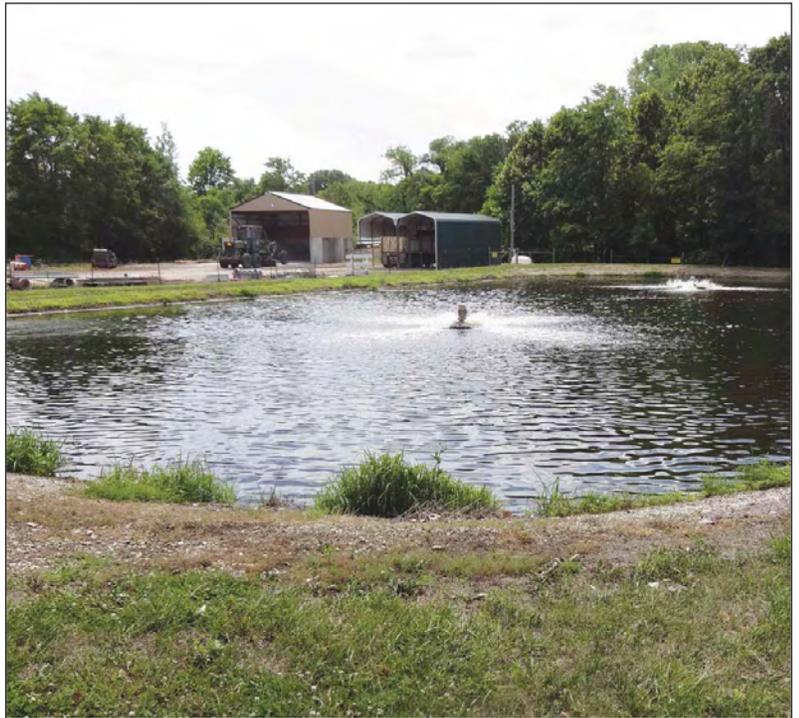
The 0.9-acre primary cell (Cell 1) of Lecompton's lagoon is equipped with two, five horsepower surface aerators to keep dissolved oxygen at satisfactory levels. This cell had four feet of sludge on the bottom that was eventually removed and land-applied.

In September 2019, the city contracted with Hodges Farms and Dredging of Lebo, Kansas to remove sludge from Cell 1. During the removal process which required four days, all incoming raw flow was directed to Cell 2. Clearer water was also pumped off the surface of Cell 1 to Cell 2. Then the sludge slurry on the bottom of Cell 1 was pumped and loaded onto tanker trucks. The sludge was taken to nearby cropland and land applied. The sludge was surface-applied by the contractor and then disked in by the farmer in order to meet the Vector Attraction Reduction requirements of EPA's Part 503 Sludge Regulations. The total cost for sludge removal was \$78,480.

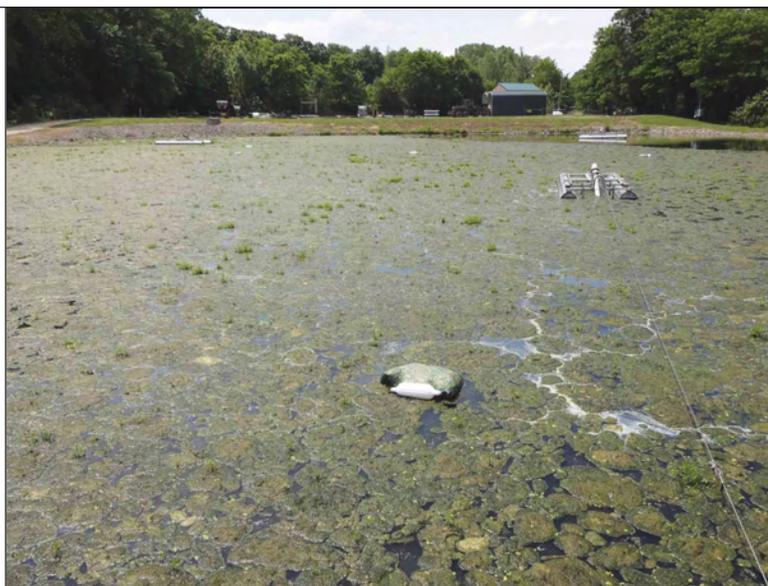
**This photo shows Cell 2 completely covered with filamentous algae mats. These mats block sunlight which is needed by algae to produce oxygen needed by bacteria to break down organic matter. Such a situation can adversely affect treatment and effluent quality. The mesh bag with float in the foreground is barley straw introduced to control the algae.**

area of the cell. Treatment was severely compromised. A sample of the algae was provided to KDHE biologists to confirm it was indeed of the filamentous type. This variety of algae presented in large, flat oval shaped masses that were very effective at blocking sunlight and adversely affecting treatment. Operating the aerators in Cell 2 did little to disperse the algae mats or provide sufficient levels of oxygen. KRWA and the city officials consulted with KDHE staff who recommended trying to control the filamentous algae using barley straw. References indicated that by adding barley straw to the lagoon and allowing it to decompose over time, hydrogen peroxide would be released. Hydrogen peroxide is toxic to algae.

Originally, KRWA staff tried to locate a local source of barley straw. Local breweries were contacted only to find they shipped in their barley from across the U.S. KRWA also contacted the Kansas Department of Agriculture to possibly locate nearby farmers who grew barley; none could be located. Finally, City Clerk Lynley Sanford located a supplier of barley straw in New York who provided the straw mainly for algae control in ornamental ponds. An order was placed and straw bales arrived at Lecompton shortly thereafter. The bales of barley straw were then broken up and placed in mesh bags with floats attached. These were launched onto the surface of Cell 2 to hopefully control the filamentous algae. While it took almost two weeks to begin seeing signs that the barley straw was effective, the application eventually yielded good results. However, the major drawbacks of using barley straw is that it is rather expensive (including shipping from distance) and labor-intensive for setup and then replacing the decomposed straw every several weeks after introduction.
