KRWA Assists with Pigging Raw Water Line at Geary RWD 4

About the district

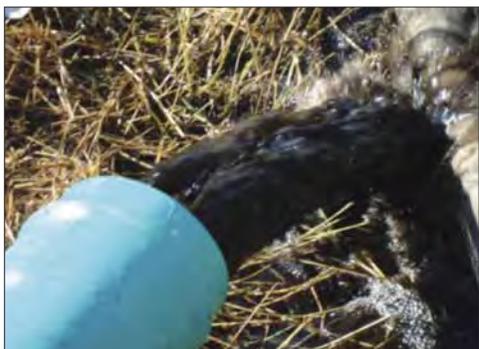
This photo shows the start of "dirty water" (high content manganese and iron deposits) during pigging of a pipeline on another project KRWA conducted.

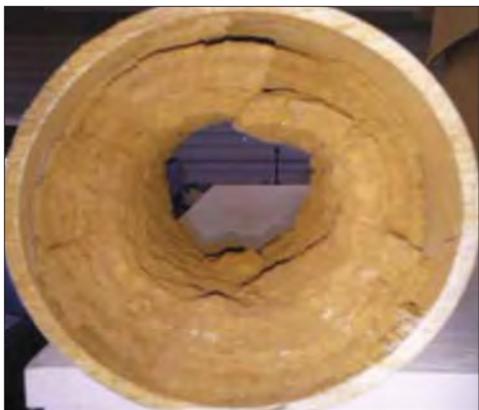
This photo shows the buildup from iron deposits in a 3-inch PVC line. This pipe is from a smaller city in northeast Kansas where KRWA staff assisted with pigging.

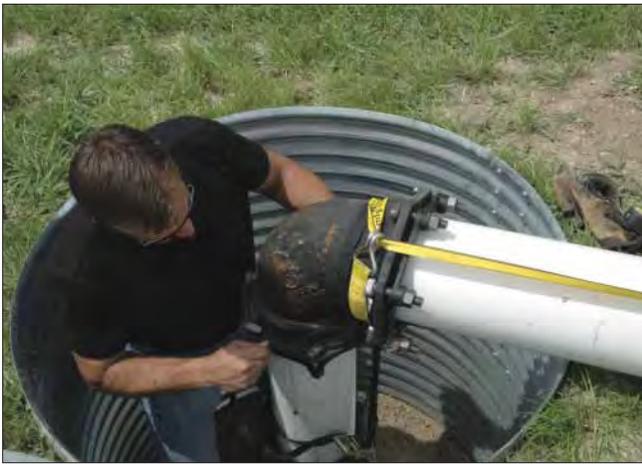
Preparing for a pigging project requires having a port to launch and an exit point. KRWA staff member Greg Metz is shown here tightening MJ connections to hold the piping together. Straps were added as an extra measure.

After meeting with Cliff and reviewing the proposed project, we wanted to be sure to cover any issues for the path the swab would take. We tried to confirm any services, Tee's or any changes in route that could create a problem in disrupting the pig's path and causing it to get stuck. We installed the pits and ports to allow for the launching and exiting of the pigs.

On the day we worked on the project, we first connected the riser and pipe at the exit pit to direct water away from the area and to ensure no damage would be caused because water flowing from the discharge point. Given the length of the pipeline to be pigged and knowing the flow rate and pipe size, we calculated the time required for the foam pig to travel the distance from the well to the treatment plant. We estimated it would take about 27 minutes to reach the plant exit point.

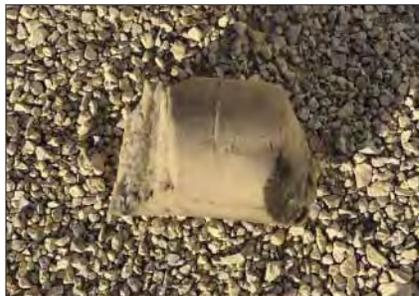
There were only a couple of possibilities. I learned later that the district had installed a check valve at the midway point of the line at the top of a small hill. Usually, a soft swab type pig would have passed such a swing check. This valve, however, had a center pivot with two halves. The

district excavated the valve and opened the pipeline at that location. Sure enough, the swab was stuck in the one side of the check valve.

The photo shows the foam swab (pig) after it was retrieved from a check valve. It was caught in the system for several weeks.
