Change in well – change in water quality

Recent Examples of Kansas Public Water Supplies Addressing Well Water Quality

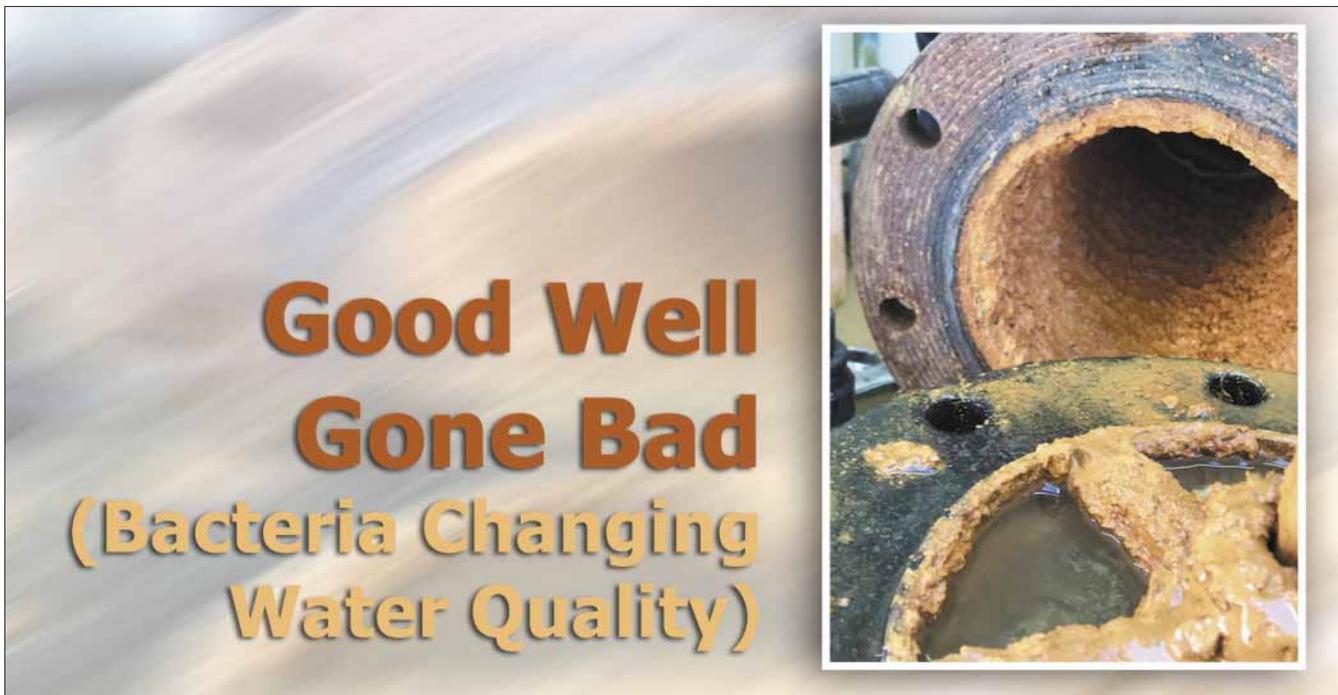
This is a photo of the column pipe showing corrosion inside and out along with biomass buildup.

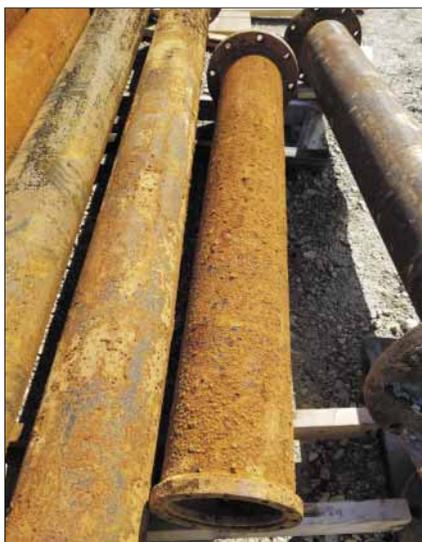
Shown above is a column pipe joint that has been unbolted and separated. The wheel looking piece is called a spider; it has a bearing in the middle that the line shaft runs through. It minimizes the shaft wobble of the line shaft that runs from the motor on top to the pump impellers. The buildup is iron bacteria slime and biomass.

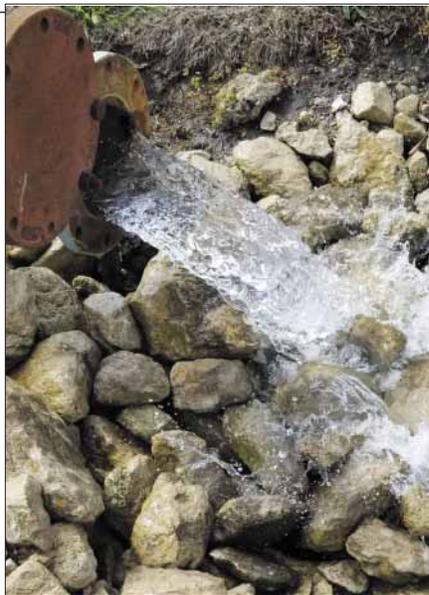
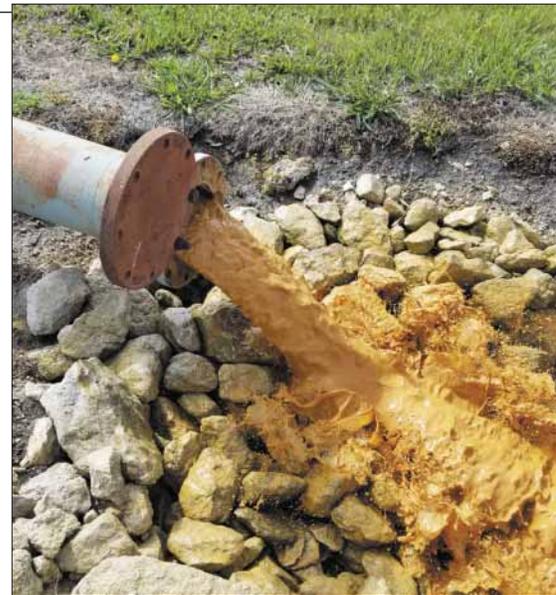
These two photos show water running clear, then not so clear – are the results of a line pigging procedure. The clear water was 12 minutes into the pigging event and the murky water was after 25 minutes. This water system routinely pigs the line from the well field to the water plant on a quarterly basis.
