Sanitary Survey Initiates Replacement of Tank Vent – Unnecessarily

All about storage tanks . . .

Storage tanks damaged during the Big Freeze in February 2021

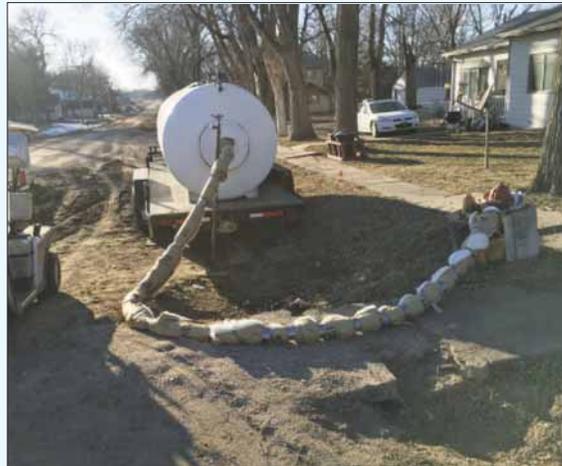
KRWA provided assistance to the city of Republic by setting up one of the Association's potable pressure tanks. Insulation was added to help prevent freezing of connecting piping.

warming over the next few days, KRWA Tech Greg Metz was able to dispatch and set up one of KRWA's portable pressure tanks, to allow some relief to the well pumps and to cycle as necessary. With the ingenuity of the operator and a local contractor, the insulations was removed at the base of the stem pipe and forced heat from a salamander style portable heater on the pipe until the stem pipe thawed. That only resulted in the water that remained in the tank to drain

The pressure tank would be used for several weeks following until repairs could be made.

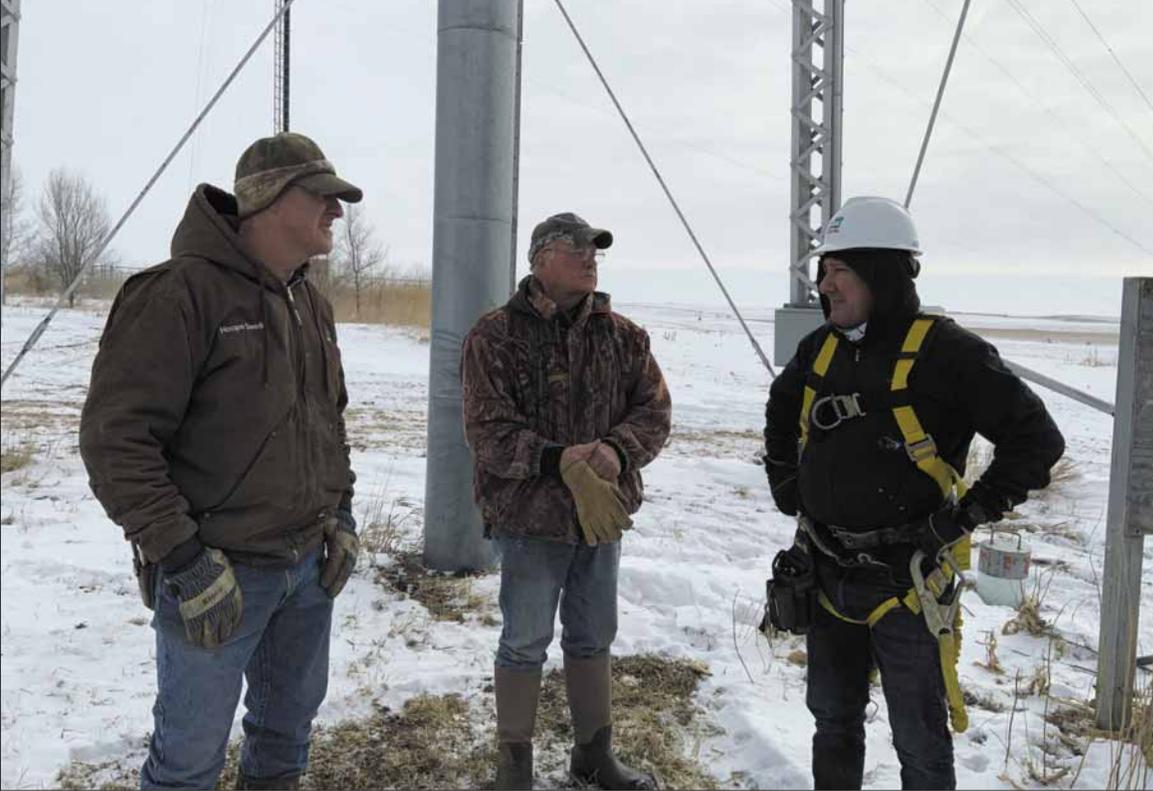
Tony Grant (on right), Maguire Iron, discusses options after inspecting the water storage tank at the city of Republic with Operator Jim Elliott and Mayor Randy Thayer.

City of Republic Operator Jim Elliot, contacted KRWA early on February 16 for assistance with potential leak and frozen storage tank. The temperature was -20°. The stem pipe had frozen solid and caused an over pressure situation when the well pumps came on, resulting in a blown 4-inch main. After assisting with the

main repair having to get through 24 inches of frost, pumps were operated continuously with a relief valve installed on a fire hydrant. The damage to the tank was extensive. The tank inspection/repair crew would have to either wait for the everything to thaw out or thaw it and drain it by using steam. With the weather

Luckily the city had great insurance and the repair costs that were over \$100,000 were covered mostly by insurance. The tank repairs were made and it was returned to service. Sandblasting and painting would follow.

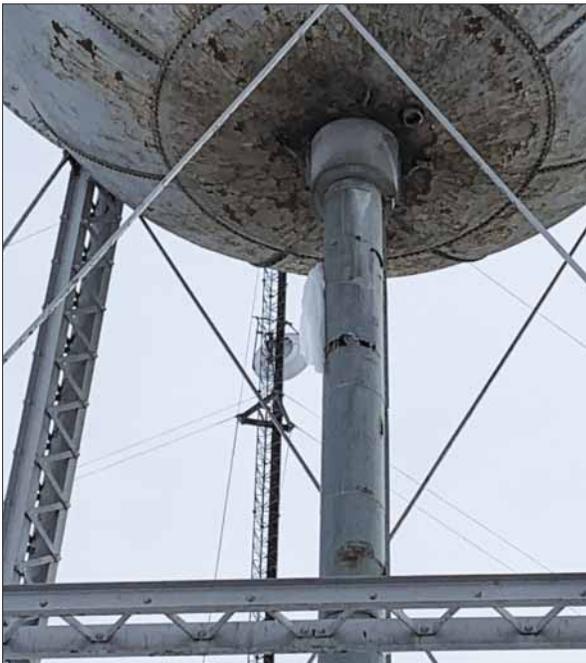
The stem pipe at Republic broke just below the bowl of the tank. Note the four-foot chunk of ice on the pipe.

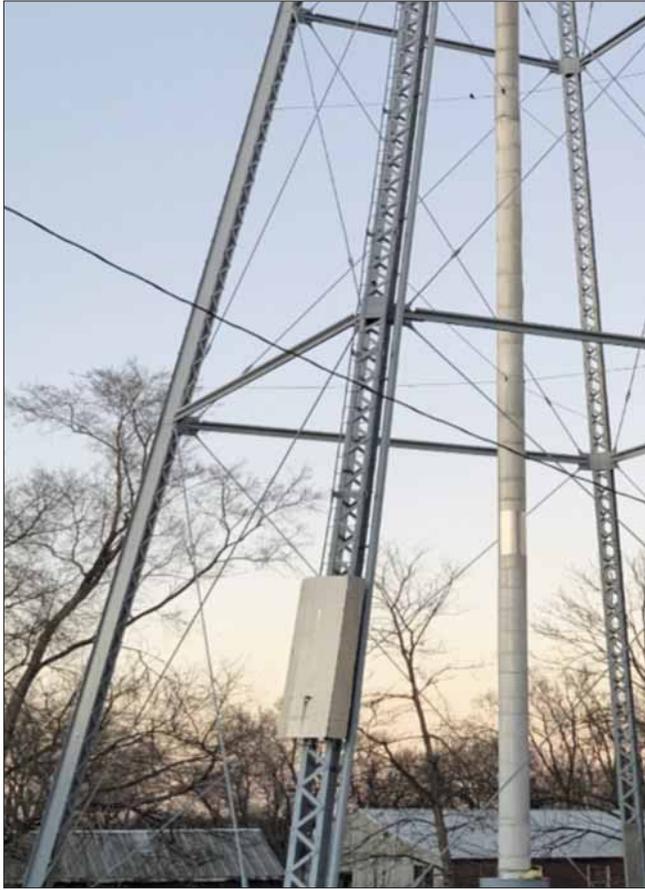
Since 2001, water storage facilities have been designated as federally-protected site. Access should be restricted through multiple layers of protection such as the ladder guard shown in this photo.

It is essential to know that since 2001 water storage facilities have been designated as federally protected sites. Consider restricting access to water storage tanks through multiple layers of protection. Protective methods can or should include locked fences, locked access doors with swipe cards or coded entry, locked hatches, intrusion switches or closed-circuit television monitoring. If a private company requests access to any system's storage tank, verify the individuals' identities and purpose are confirmed. Consider accompanying them also. Due to the tank's design and its location, a fabricated modification may be warranted to impede undesired intruder access. The installation of a locked aluminum cover over the access ladder and the addition of metal bars to the ladder cage is a good example as shown in the photo top left.

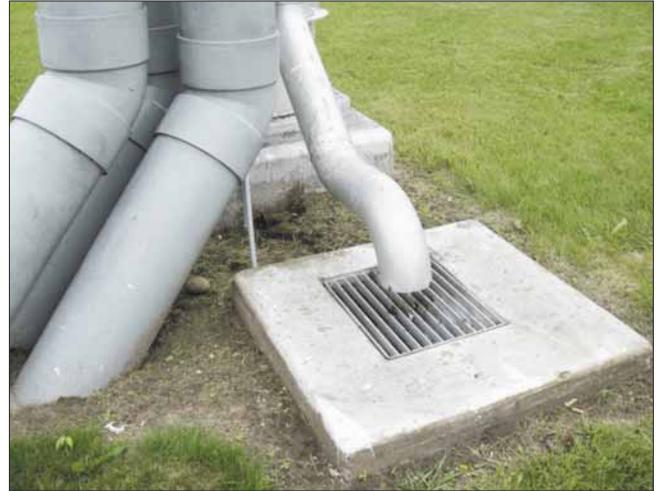
Tank overflow pipes need to be adequately screened and should have adequate relief of the overflow pipe within 12 to 24 inches or an air-break above the ground.

with termination at 12 to 24 inches, or an air-break above the ground. This separation is in part, so flooding the area will not result in siphoning of contaminated water into the tank. The overflow pipe should be cut off high enough above the ground to allow for the installation of an elbow to direct flow to an inlet, or splash pad to prevent erosion. The overflow pipe should not terminate below ground. During a control communication failure, the operator would not see the tank overflowing.
