# Friends Are Important; Sometimes, It Takes a Village

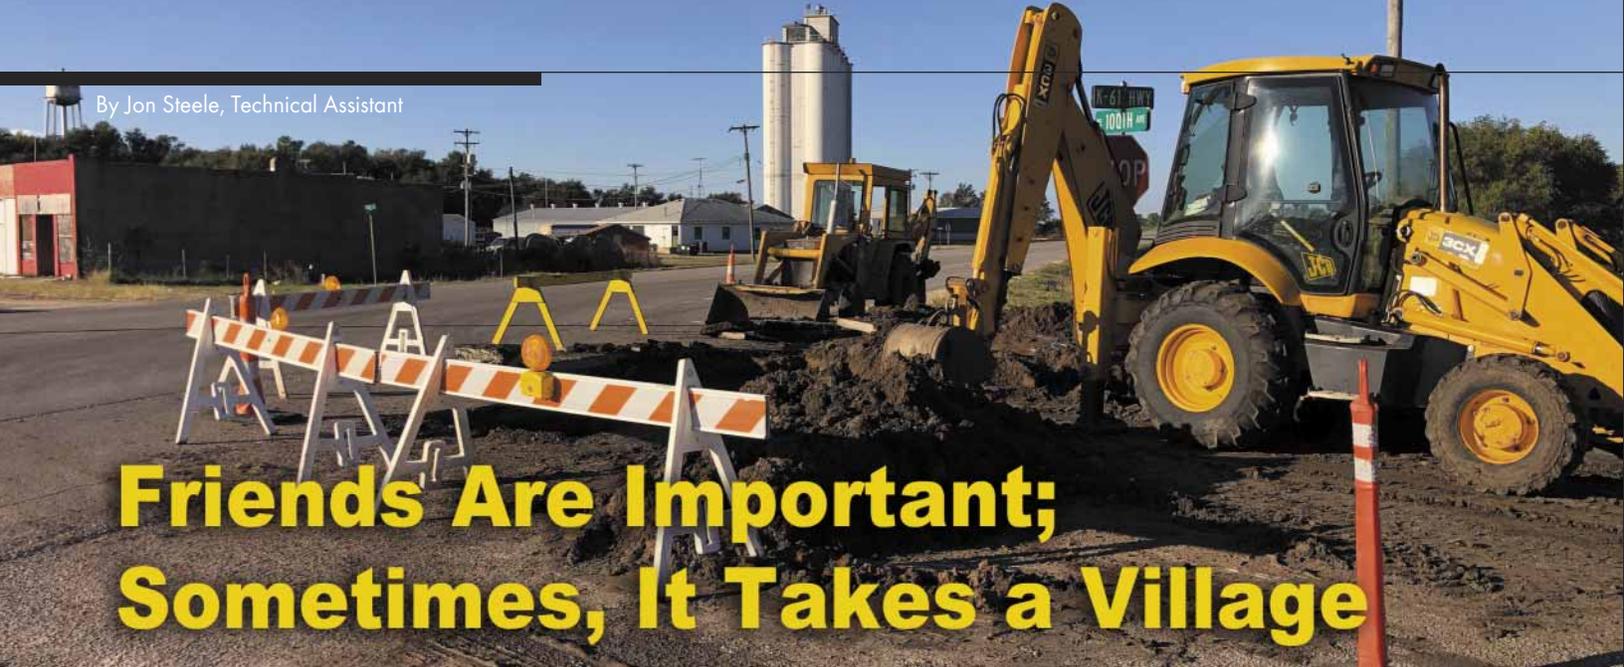
This photo gives an idea of just how dangerous a recent waterline repair was. The 6-inch line crosses the highway and immediately parallel is a major railroad track.

along the town's Main Street. Fifteen feet of the original cast iron line including the tee and reducer bushing were removed and replaced with C-900 PVC; a new valve was also installed.

Finally, after two days of dealing with the challenge of being within five feet of a 70 mph traffic lane including semi-trucks and inattentive drivers we were finished. The excavated site was filled with flowable fill. Water was restored however a boil advisory was in effect pending the results of a bacteriological sample. Extensive flushing was done to remove air from the system and to bring the chlorine residual up in all corners of town. The next day four samples were taken and I delivered them to a local lab for bacteriological analysis.

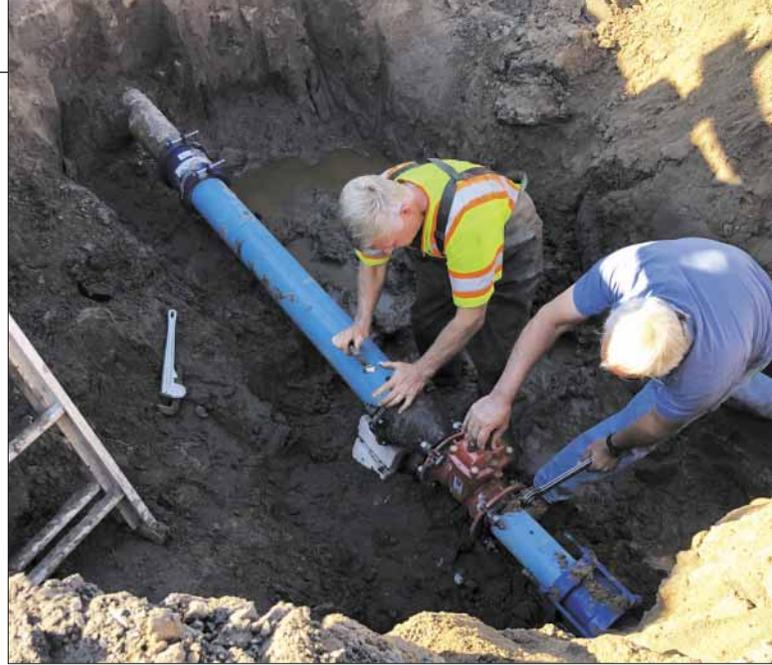
When we finally located the line, it was not where the maps indicated. The location matched the recollection of the former operator concerning the water main he had repaired years ago. He had cut the portion off that went under the highway and left a short piece stubbed out of another main and capped it, also capping it on the unpaved road that intersected the highway to abandon that section under the highway. Two of the bolts on the 4-inch MJ cap were completely gone and the cap blew partially off causing the leak. The other two bolts on the cap were very thin and shaped like an hourglass. We could have replaced the cap and called it good but decided to fix it right and remove the tee and a section of the 6-inch line. These were all original 1913 sand cast iron lines. This line was also the main transmission line running under the state highway

**When the highway was reconstructed years ago, it resulted in the city's water main being incredibly deep as this photo shows. Shown are KRWA Technical Assistant Jon Steele and Everett Higdon from the neighboring town of Turon.**
