How Aerial Photography Helps Locate Water Lines

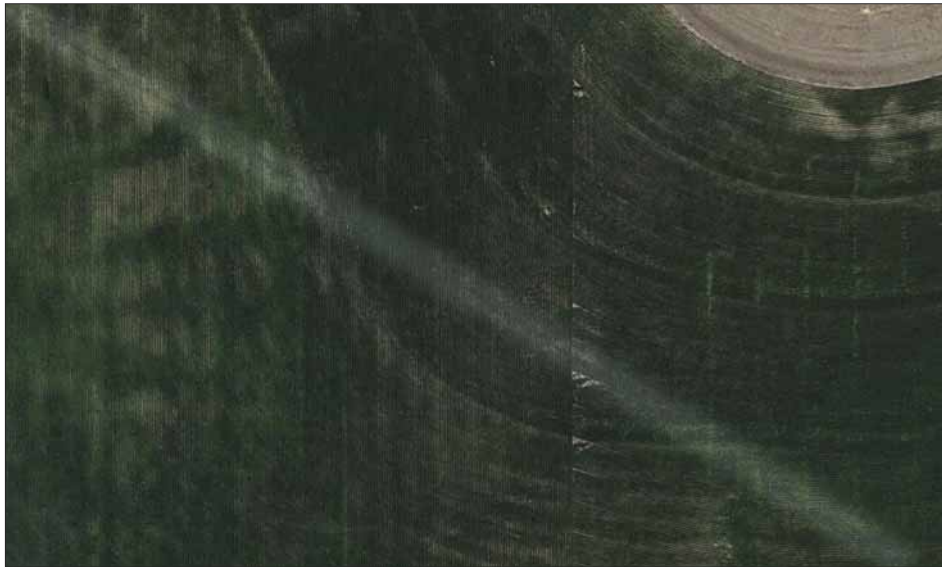
The pipeline trench that crosses under this cornfield in Clay County in Spring 2021 imagery can be detected (in the highlighted area), even though the pipeline was installed decades ago.

Cultivated farm ground is still a lot more difficult, even with high-resolution imagery, to locate old water line trenches. Periodically, I'll find the location of the trench line, where there is an apparent different shade of green stripe through the growing crops. I believe the time of year the imagery was captured also makes a difference. In my experience, I think imagery that shows crops early in the growth phase from April to May, or in August when the crops are likely struggling for moisture, enhances the chances of locating the trench lines. The imagery of pastureland after control burning also really helps out. The size of the trench that was dug also makes a difference, as three large natural gas/oil pipelines installed in 1952, 2008, and 2010 run through extreme northeast Kansas and are all visible through all types of ground as shown in the graphic.

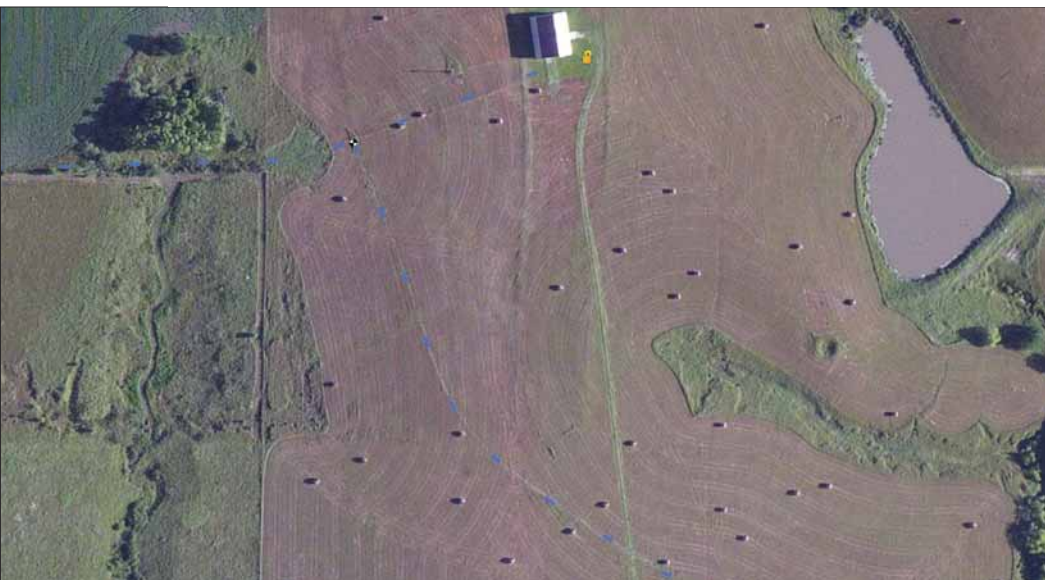
The blue dashes indicate the location of another "cross country" water line in Morris County. The trench line is very apparent in this aerial 2021 image. The pipeline was installed a few decades ago through native tallgrass prairie.

definitely consult with their local NRCS office. Today, Pottawatomie RWD 2 and many other RWDs are utilizing Google Earth to view their mapping data and multiple years of aerial imagery as a background layer. Depending on the area, users can view imagery years from 2022 and earlier usually every other year to 2001, then to 1991, and then to 1985. But the 1985 imagery is very fuzzy and only reveals a little. From 2012 forward, the imagery is all high resolution, clearly revealing trench lines, especially through Flint Hill pastures.
