Topeka Air Industrial Park shows innovation in tank renovation

Keeping the system under pressure during tank rehab

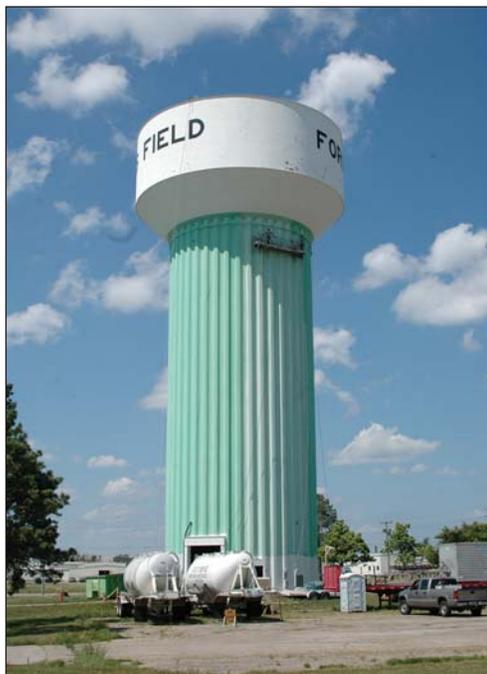
Above left: The .75 MG storage tank was added in 1987, replacing a WW II era concrete water tower. The same year the facility's original cast iron water system was replaced with C-900 PVC with ductile iron pipe placed under the roadways.

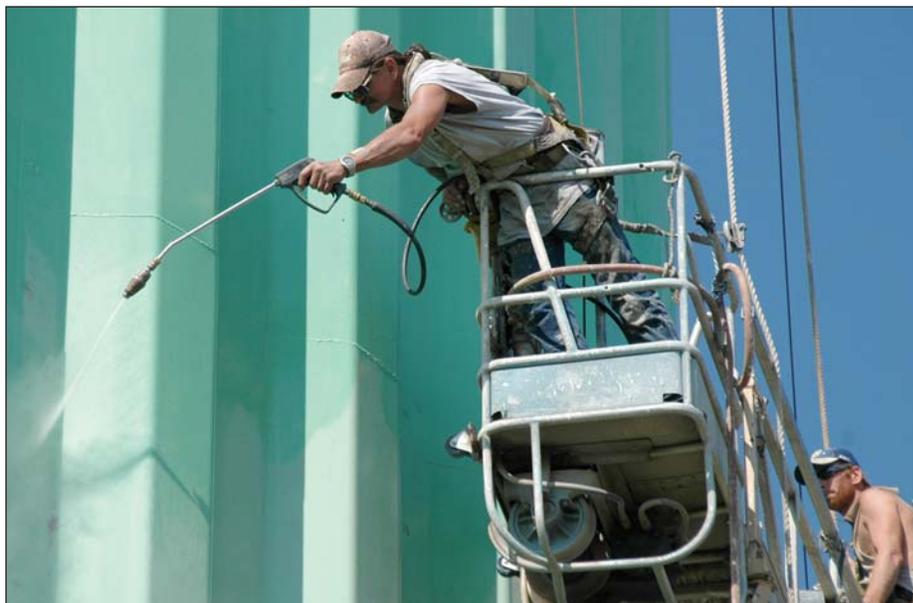
Above: Michael Jacobberger, owner of J & D Painting and a subcontractor for Utility Service Co., Inc., power washes 21 years of weathered scum from the storage tank's original paint. MTAA has a maintenance contract with Utility Service Company of Liberty, Mo.

The MTAA board decided to tackle the loss of chlorination problem initially with a total renovation of both tanks that included interior sandblasting, new interior epoxy paint, exterior high pressure wash, and new exterior paint. It was also decided to install the Solar Bee, high volume, floating recirculation system units in the tanks. A maintenance contract was signed, guaranteeing annual tank inspections, annual maintenance if needed and future renovation when tank conditions dictate that it is needed again.

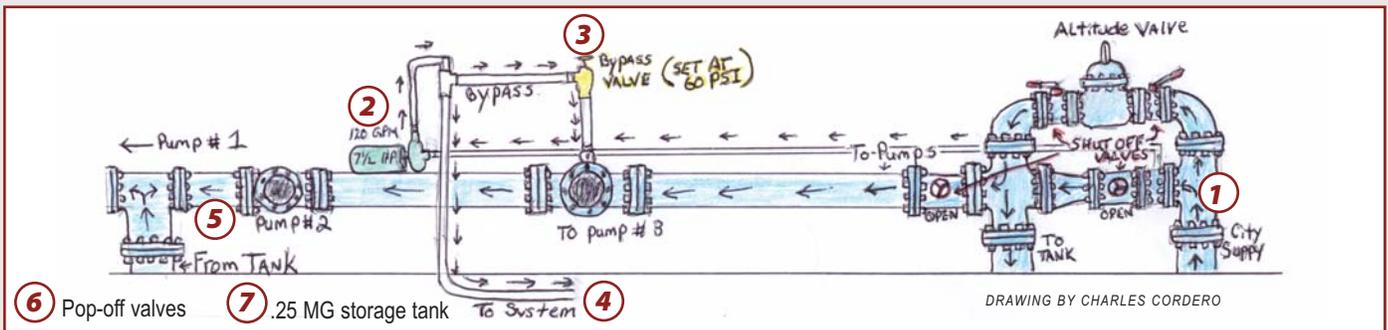
When describing the temporary plumbing loop utilized to keep the MTAA water system pressurized during tank renovation, Charles Cordero used his drawing above to help follow the process. It's used again here with the photos to help with the explanation.

- 1.** Topeka water from the .25 MG storage tank enters through the 10-inch line and is accessed by plumbing through an 1.5-inch hole, cut with a hole saw in the ductile iron fitting. The loop system has three access holes at points 1, 3 and 4.

- 2.** The 7-HP, 120 GPM, 3-phase pump pulls water from the storage tank on the supply side and pumps water at 60 psi to the system side through another 1.5-inch access, pressurizing the system. This is seen in the illustration and photo at point 4.

- 3.** The 60 lb. psi is determined by the mechanical setting on this by-pass valve. When the pressure in the system exceeds 60 lbs. psi, the by-pass valve opens and routs the extra water back into 10-inch piping return to the storage tank, lowering system pressure. Normal operating pressure when the large storage tank is in use is 55 lbs. This loop system allows for a little more operating pressure.

- 4.** The temporary pressure loop holds system pressure steady at 60 lbs. psi.
- 5.** In case of a fire, the system utilizes three pumps in the pump house, the smallest rated at 480 GPM. Activating one of the pumps would instantly blow out system lines. To counter this, six pop-off valves are utilized throughout the system, affixed to system fire hydrants. A pop-off valve can be seen in hydrant photo 6.

"The bids for a pressurized tank ran over \$11,000 for 30 days and \$250 per day after that. We would have needed it for 60 days at least." Cordero stated. "My assistant operator Rod Niehaus and I put our heads together and came up with another solution. We designed a looping pressurization rig that includes a 7.5 HP, 120 GPM pump, a by-pass valve and PVC plumbing and hardware for a total cost of \$2,000. We installed it the first of July and it's worked

like a charm ever since." (See the sidebar on the previous page on how the temporary pressure loop system works.)

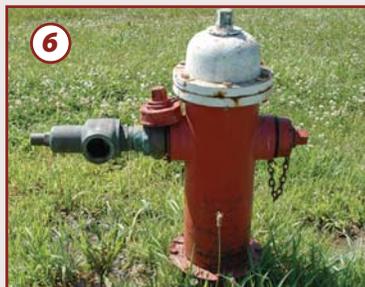
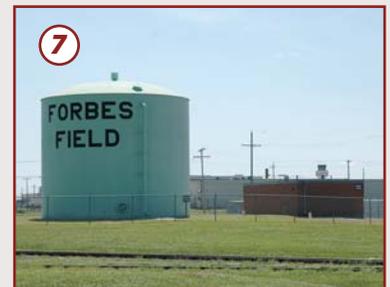
- 6.** The pop-off valves, which are pre-set at 65 psi, assure any instant increase in pressure caused by the activation of a large pump will not cause any damage to the system. Also, if a very large fire increased water volume needs, additional drawdown from fire department pumping would allow the other two system pumps to join the first, and still not damage the system.

- 7.** The .25 MG ground level storage tank is located next to the pump house. It is manually topped off daily when the pressure loop is in use. This is accomplished by opening and closing the feeder valve outside at the back of the building. The tank volume can sustain the loop system for three days with normal operating water usage. The MTAA system draws Topeka water from the tank rather than directly from the feeder line. This ensures the city feeder line will be safe from water hammer when the large pumps might be turned on.

The temporary set-up also utilizes six, two-inch pop-off valves that are also described in the sidebar. They are installed on fire hydrants spaced throughout the MTAA water system. These were borrowed from Topeka City Water Department and Utility Service Company.
