Problems Meeting Discharge Permit Limits

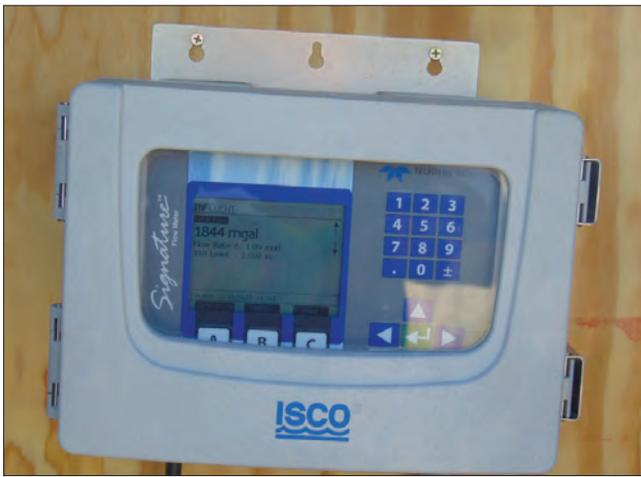
Pictured here is an influent flow meter to a lagoon. Knowing the daily flow into the treatment is very beneficial to be able to operate and ensure effluent limits are met.

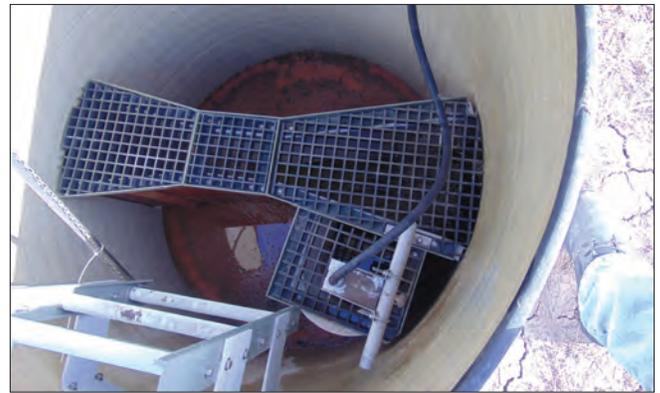
This effluent flow meter was recently installed on a lagoon discharge to monitor the discharge rate of the lagoon. This installation is unique; it is also solar/ battery operated.

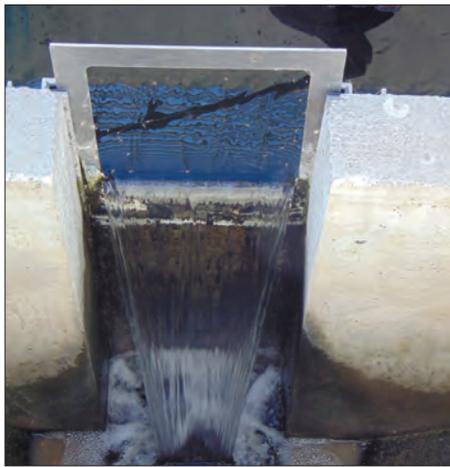
The effluent is extremely clear. This is common when a lagoon is operating efficiently.
