# GOOD WATER QUALITY WELLS GONE BAD

**K**ansas has many good water-quality wells serving cities and RWDs and others. These wells are a result of good water quality aquifers, adhering to good construction standards, and testing water quality before construction.

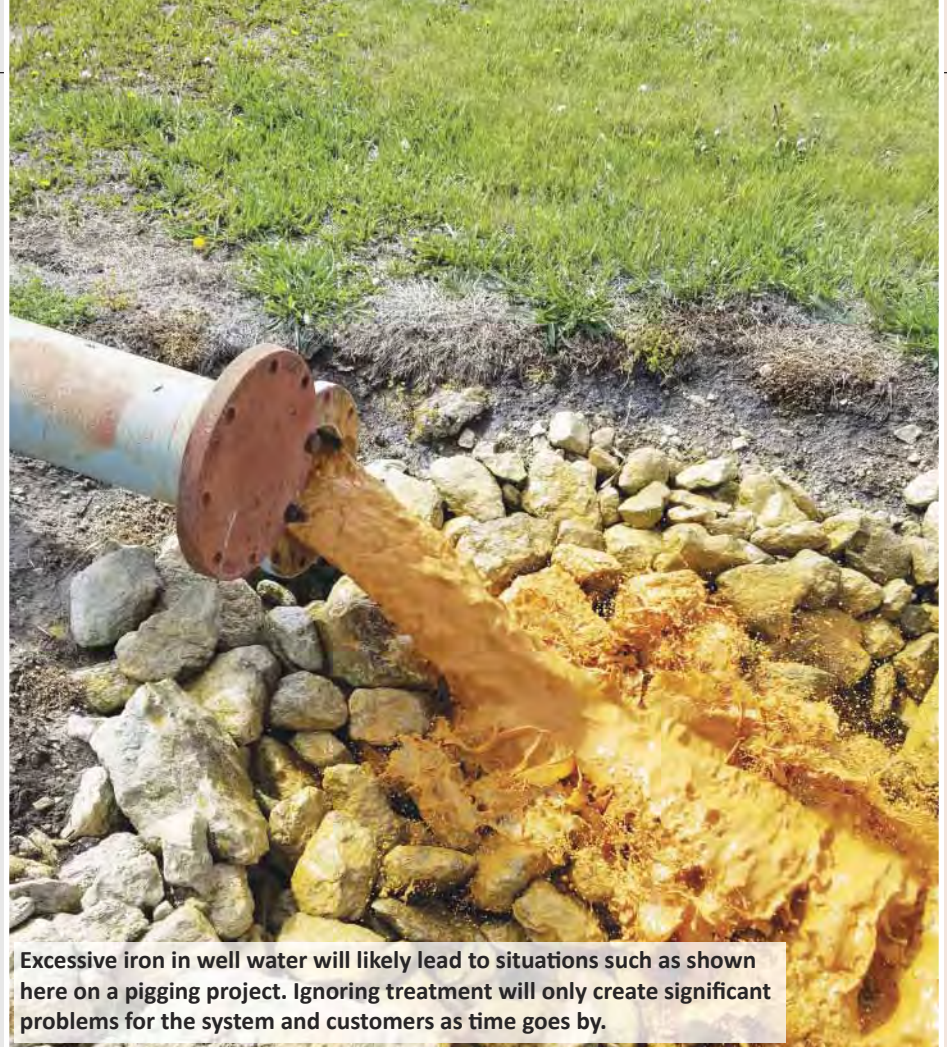
Excessive iron in well water will likely lead to situations such as shown here on a pigging project. Ignoring treatment will only create significant problems for the system and customers as time goes by.

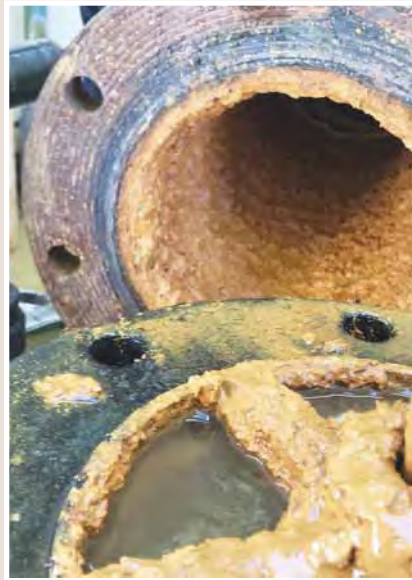
This photo shows iron deposits and bacterial growth inside the well pump discharge line.

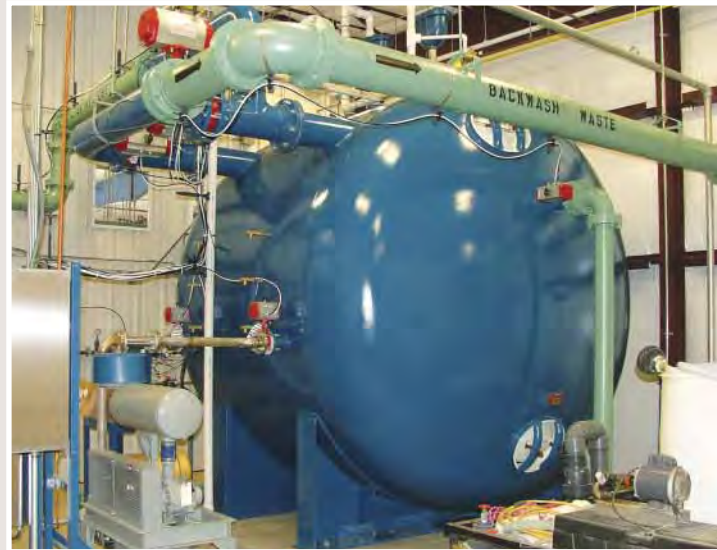
Avoid water treatment for well water if possible. First, evaluate the well for changes in water quality. This photo shows a pressure sand filter to remove iron in a rural water district plant located in northeast Kansas.
