Do YOU have demons in your water well?

Jon Steele
Tech Assistant

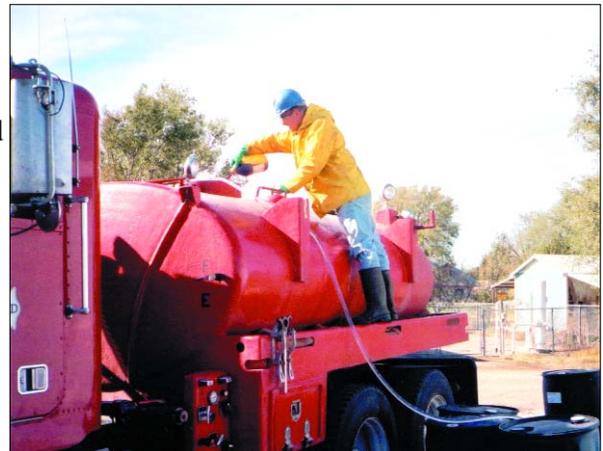
Treating the well at Beverly required 20,000 gallons of 1000-ppm chlorine solution and 15 quarts of liquid soap as a wetting agent.

1. A local fire tanker truck was used to mix the solution and pump the chlorine solution into the well.

2. The solution was then surged back and forth from the tank into the well for two full days. The surging of the pump creates a mixing and washing action to penetrate and dislodge the slime and biofilm that are associated with bacterial growth in the well and surrounding formation.

3. Next, we allowed the solution to remain in the well over the weekend.

4. The next week we pumped it to waste. It takes a lot of pumping to flush out this much wetting agent but it does a nice job of assisting the chlorine to reach the slime.

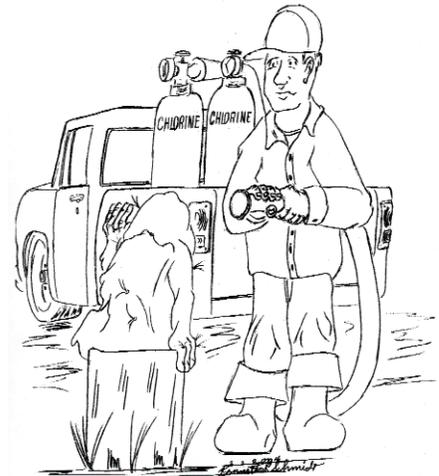
Capt. Chlorine wins again!

The acid treatment on this well greatly improved pumping capacity. Originally, the pump would break suction at 50 gpm. Following treatment, the capacity increased to 142 gpm. It marked the end of another successful effort by KRWA to help water systems.
