Well maintenance cleans up problem for Miltonvale

Late in July 2009, William Jackson, the new operator for the city of Miltonvale, contacted me about chlorine residuals dropping dramatically in water produced by the city's Well No. 8. Miltonvale is a town of about 500 people and is located in southeastern Cloud County.

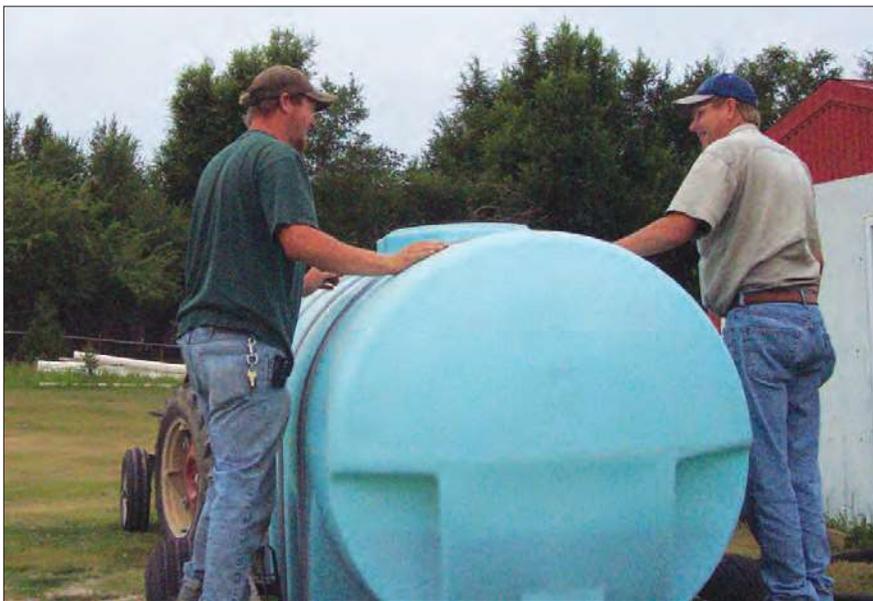
William Jackson, Operator at Miltonvale, and KRWA Tech Doug Guenther discuss the chlorination treatment. The goal was to treat the city Well No. 8 with a 500- to 1000-mg/l chlorine dosage to remove iron and other bacteria.

The goal was to treat the well with a 500- to 1000-mg/l chlorine dosage. We mixed ten gallons of 12.5 percent sodium hypochlorite with 500 gallons of water and drained the mix into the well. We then pumped 1,000 gallons of water from the well back into the tank. We added one quart of Ivory dish soap to this mix. The mix was drained back into the well. The tank was filled and drained back into the well three times. Our hope was to force the chlorine mix further back into the aquifer. After this surging, we allowed the well to rest for 24 hours.

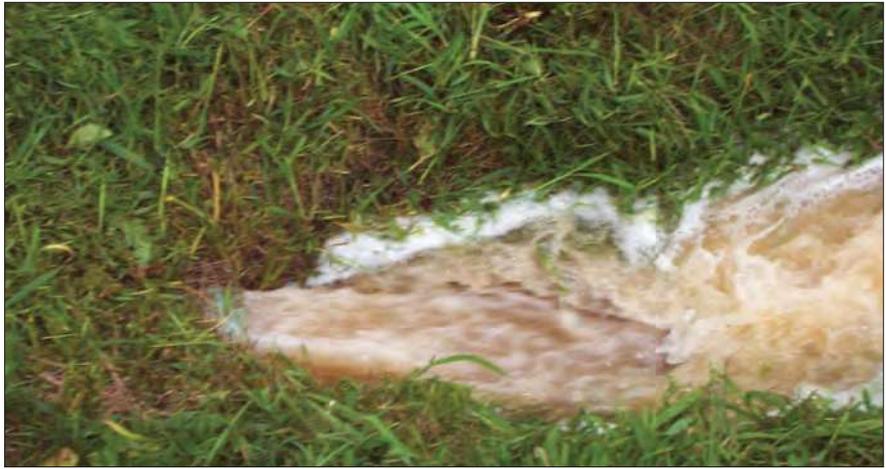
Water pumped from the well after surging the 1,000 gallons of highly chlorinated water in the well contained a lot of brown, soft material with the consistency of algae slime and small chunks of rust and very brown water.

The next day, we pumped 1,000 gallons from the well into the tank. There was a lot of discolored water and suds. We continued pumping the well, flushing the remainder of the chemical to waste in a drainage ditch. The water in the tank and at the flush point contained a lot of brown, soft material with the consistency of algae slime and small chunks of rust and very brown water. After three hours of flushing, the chlorine residual was back to zero. The
