# HOW TO SEAL A LEAKING LAGOON

Such was the case with the city of Dorrance's two-cell lagoon system when I was contacted in March 2012. The north cell, which has a surface area of 1.25 acres, was not holding water. The purpose of this article is to provide guidance on how to properly seal an existing lagoon cell that leaks excessively.

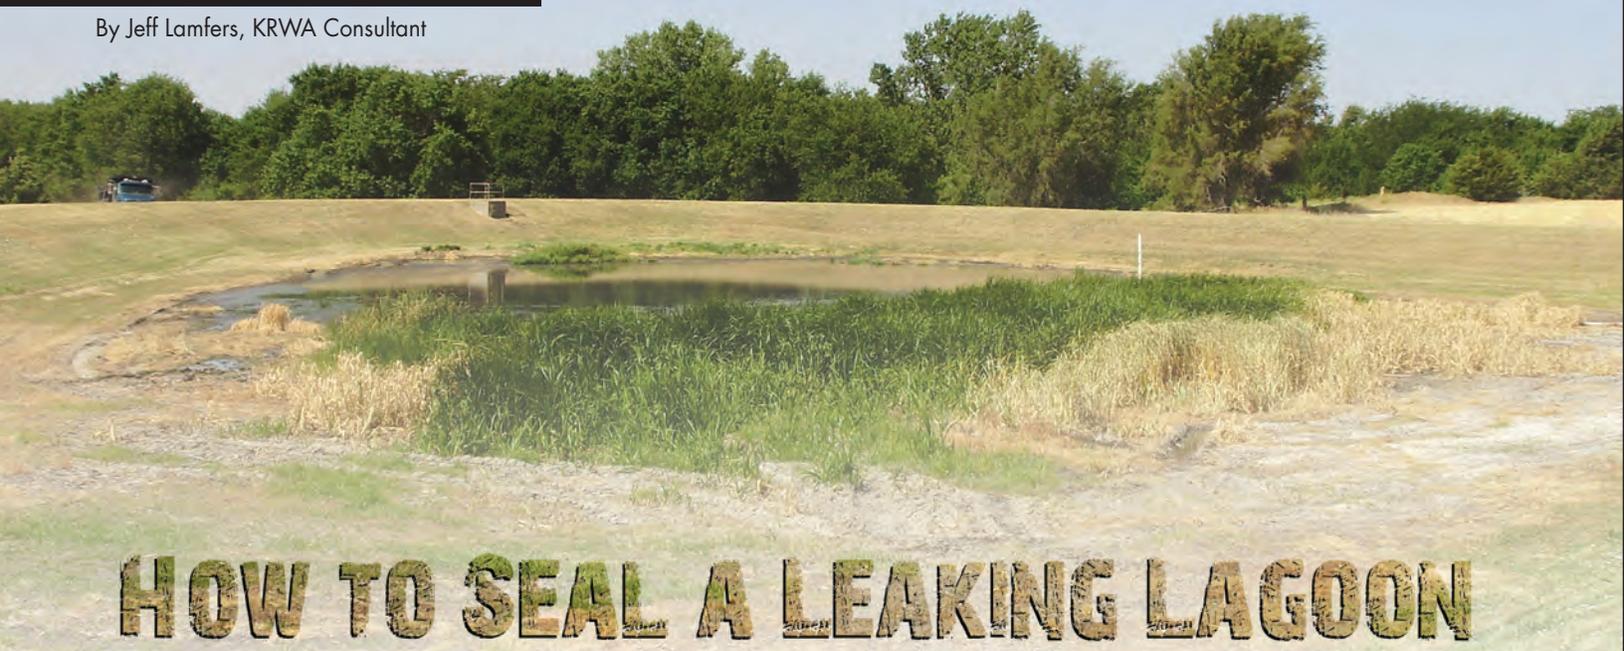
Example of a lagoon cell that leaks excessively. Minimum water depths cannot be achieved in order to provide adequate treatment and prevent offensive odors from developing. Another concern can be the potential contamination of groundwater in the area.

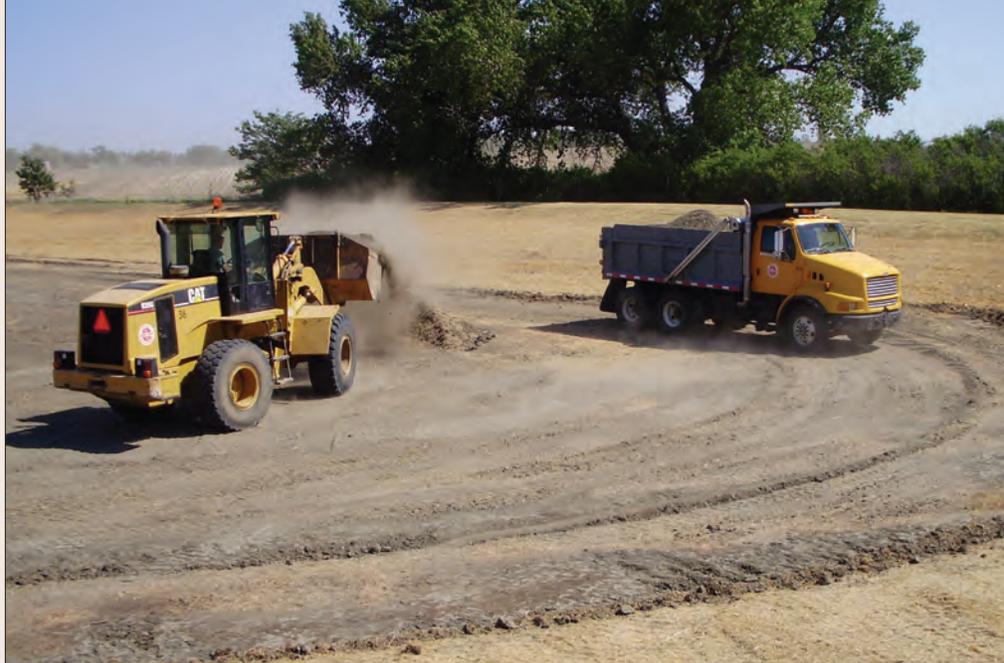
After debris is gathered into piles by grader, a front-end loader is used to load materials onto dump trucks. Most of this debris consists of minor amounts of dried sludge, dead vegetation and wind-blown soil. Such material must be removed as it does not compact well.

The next step is to remove all foreign debris that may be on the bottom or inner dikes of the cell. This includes any dried sludge left behind and/or dead vegetation. In the case of the city of Dorrance, cleaning also included a considerable amount of wind-blown soil that had accumulated over the years. These materials do not compact very well and will be detrimental when attempting to obtain optimum compaction during resealing. A road grader or maintainer is usually used to remove such material. Dorrance contacted the Russell County highway department for assistance with removing debris from the city's north cell once it had dried. The county provided a grader, front-end loader and two dump trucks to remove more than 70 loads of dried debris. This process required one and a half days to complete; costs to the city were approximately \$3,400. While most of the material removed was dried sludge and/or soil, there was also evidence of a considerable amount of vegetation that had

grown in this north cell and was likely contributing to the seepage problem.

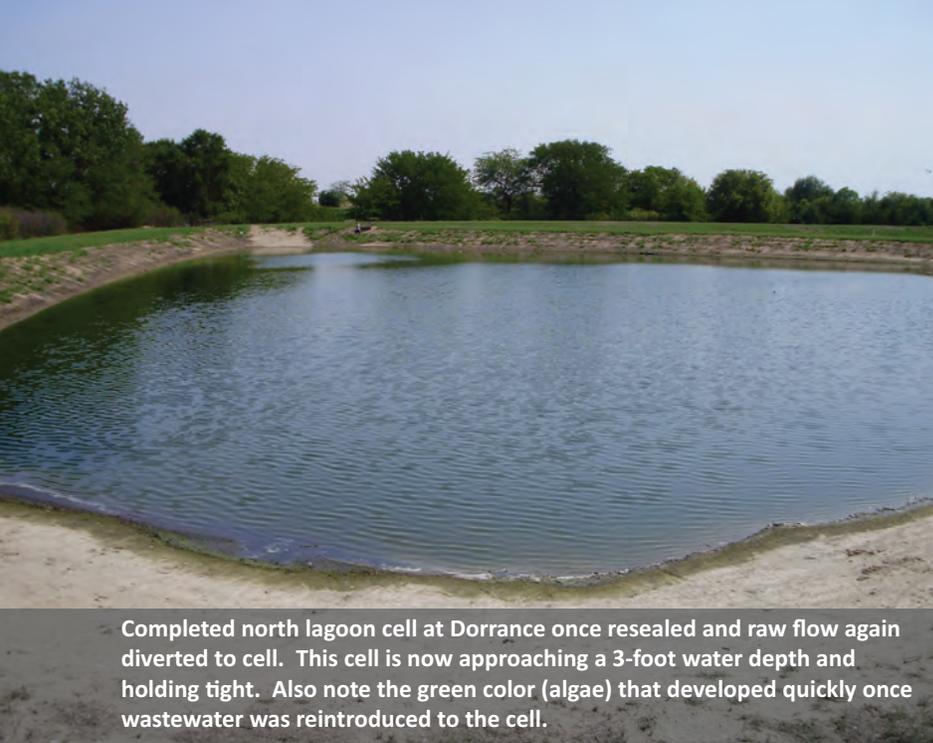
Completed north lagoon cell at Dorrance once resealed and raw flow again diverted to cell. This cell is now approaching a 3-foot water depth and holding tight. Also note the green color (algae) that developed quickly once wastewater was reintroduced to the cell.

The city installed a new influent pipe and staff gauge for monitoring water depths before raw flow was again diverted to the north cell. It was soon evident that the newly sealed cell was holding water. Within a couple of weeks, this cell already had more than a foot of water and was holding tight. Again, all this work was completed during high temperatures and high evaporation rates. It is most important that a minimum water depth of 2.5 to 3.0 feet be achieved rather quickly to prevent unwanted weed growth from developing on the pond bottom. Soil sterilants can also

During my last visit to the Dorrance lagoon in late August 2012, the average water depth in the north cell was approaching three feet. Algae were also present in the wastewater as evidenced by the green color throughout the cell. The project appears to be a success and hopefully will provide the city with sufficient lagoon capacity for many years. At least now the city has a lagoon cell that should eventually reach the desired five feet of water depth and provide treatment as intended.
