# Nitrogen Makes Things Green in Greensburg: Just Keep It Out of the Water Please!

## Case study: Greensburg, KS

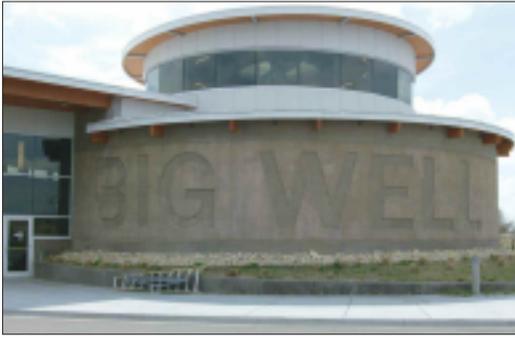
Greensburg, KS is home to the largest hand-dug well in the world. The new enclosure was constructed after the 2007 tornado. The well measures 109 feet deep and 32 feet in diameter. It was completed in 1888 when both the Santa Fe and Rock Island Railroads were laying tracks across the plains of Kansas and needed a reliable water source.

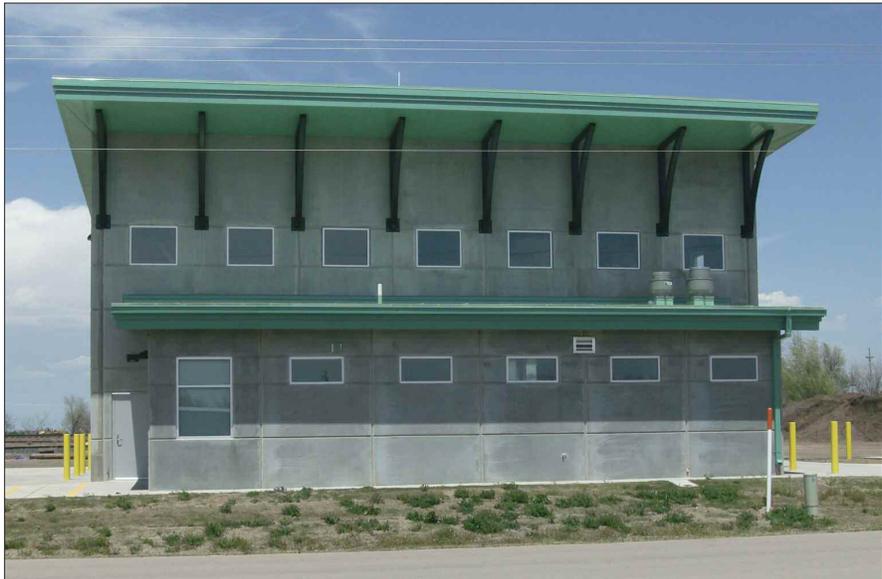
**New removal plant**

**This photo shows the new nitrate removal plant constructed in Greensburg, KS. The building is a reinforced pre-cast concrete structure that looks as if it could survive almost anything nature can send its way.**

Greensburg’s new nitrate removal treatment system is a fully automated, Layne Christensen ION Exchange system with state of art monitoring. The building is a reinforced pre-cast concrete structure that looks as if it could survive any storm nature can send its way. The nitrate skid can treat up to 280 gpm; there are three high

service pumps rated at 340 gpm to provide a blend of treated and untreated water into the distribution system. The finished treated water is stored and pumped from two 25,000-gallon tanks inside the building. The plant can be operated in a “nitrate target mode” or a “flow mode” based on the level of incoming nitrate. When the nitrate levels begin to exceed the

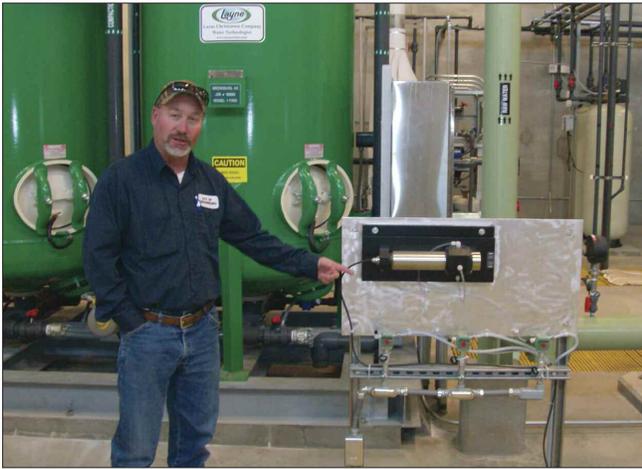
**Greensburg Public Works Superintendent Mick Kendall points out the "nitrate sensing unit" in Greensburg's new nitrate removal plant.**

set point, the operator is alerted that the filters will need to be regenerated. Any wastewater produced from the plant goes into the city's sewer system. The plant is backed up with a fully automated 100 KW electrical generator.

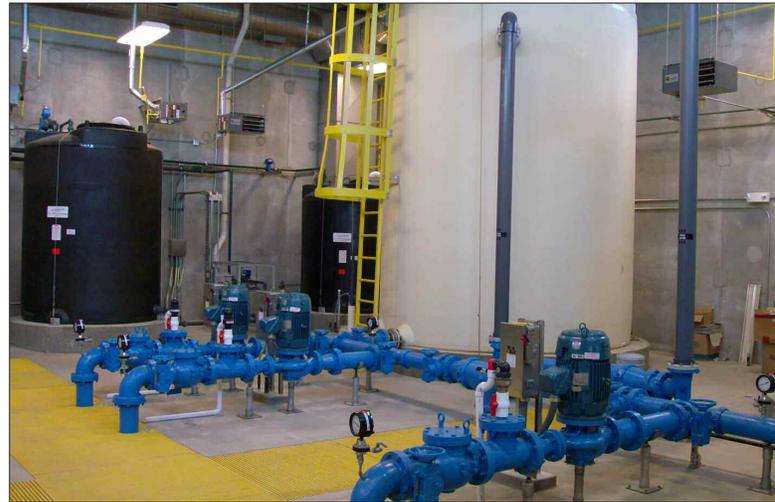
**This photo shows finished water storage and high service pumps inside the city of Greensburg's water treatment plant.**
