KRWA Helps With Cleaning and Disinfection of Flooded Water Well

Disinfection of well and system

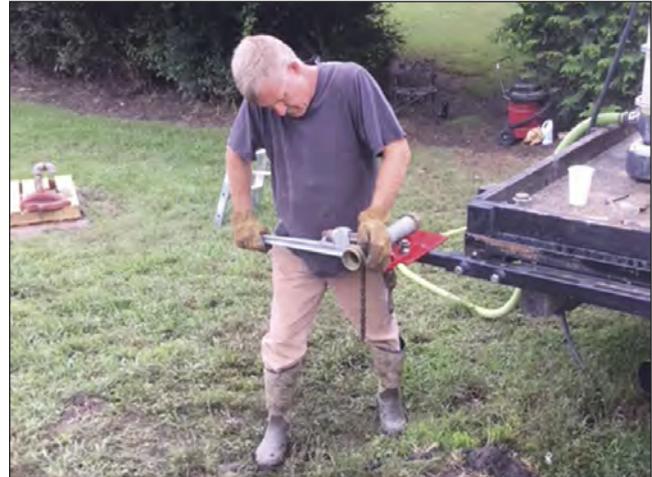
KRWA Tech Assistant Jon Steele prepares piping to allow injection of high chlorine solution to the well that had been contaminated with floodwater.

On the morning of September 11 KRWA Tech Jon Steele met with KDWP officials to assess the well and the contamination issue. Jon first prepared the equipment and piping necessary to prepare the chlorine solution and to introduce the solution into the well. It was determined that 7,000 gallons of 100-mg/l chlorine solution was needed. Commercial, liquid sodium hypochlorite solution was used to make the strong chlorine solution to be added to the well.

The chlorine solution was added to the well. The the chlorine solution in the well was pumped to the distribution systems and to all taps. The chlorine solution was allowed to remain in the distributions and in the

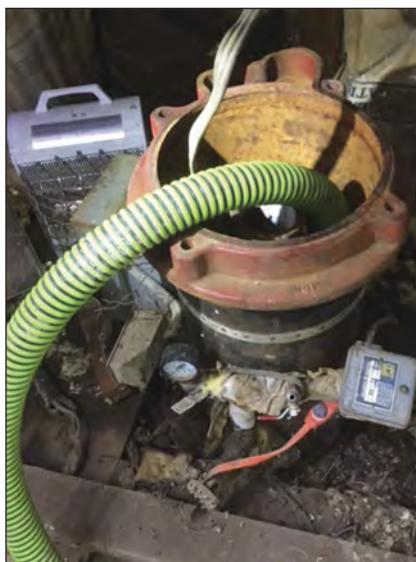
A hose was inserted into the well casing to inject high chlorine solution.

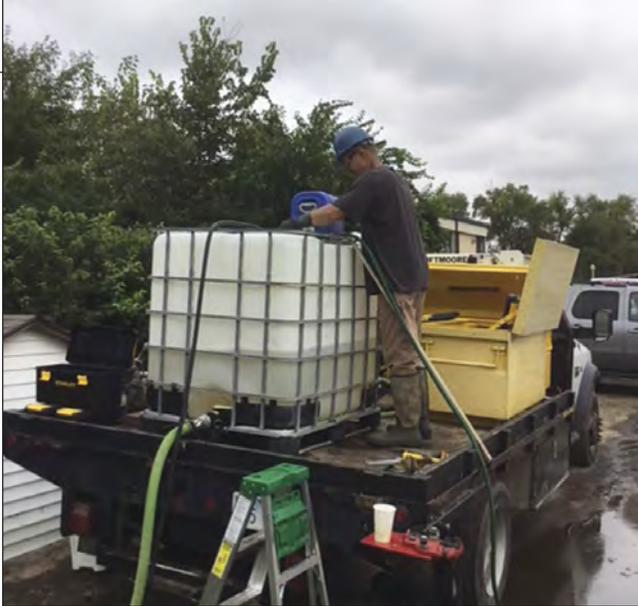
This tote was used to mix chlorine in 7,000 gallons of water that was drained into the well. The water was then spread throughout the water system and allowed to disinfect overnight.
