Addressing Water Loss and Leak Detection Requires Good Equipment and Experience Helps

Examples of two recent water loss surveys

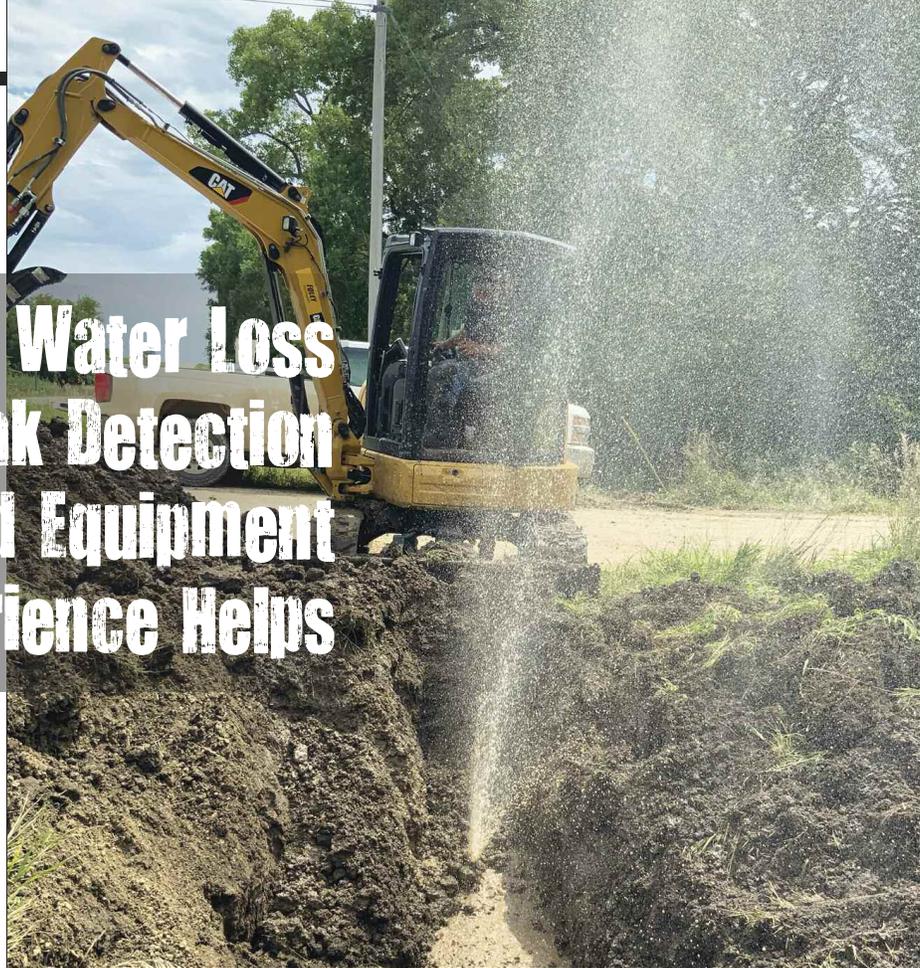
This leak was located and exposed in Dickinson County RWD 2. Having good equipment helped KRWA staff and district operators with the location.

I suggested to pot-hole the line in a couple of areas on either side of a road and creek crossings to verify possible locations of the leak. Using the Association's ultrasonic strap-on meter, we were able to determine a 40-gallon per/min leak under a road crossing. The leak was located at the edge of a roadway at a bore connection.

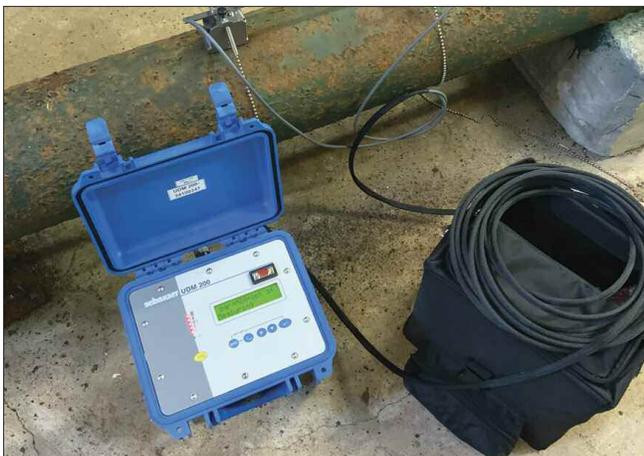
Tracking down water loss in rural water districts can be challenging. There are often long distances (several miles or more) between valves. SebaKMT recently donated this ultrasonic strap-on meter. It has been a great asset in locating leaks on pipelines where leakage is isolated within valves but still leaving miles to try to locate the leak. Creek crossings are a common place for leaks to go unnoticed. With the strap-on meter, the line is exposed; a check is made with the strap-on meter on both sides of the creek crossing without ever interrupting service or flow. Without the strap-on meter, the pipeline would need to be shut down and a new valve installed on the up-stream side, and then pressure test the line again at the main valve.
