# Antennae mania

# A contractor's observation *by James Brookshire*

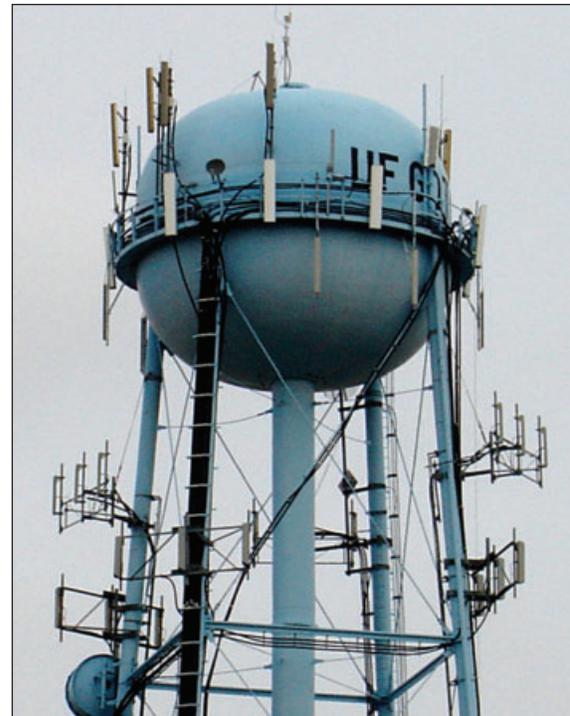
*This Kansas tower's sheer number (49) of antennae mounts and cable bundles make maintenance and painting hazardous and costly. Also, the number of RF sources could present a health hazard for workers.*

multiple antennae coaxial cable bundles ascending a structure, taking up space, the painting process becomes even more difficult. From the telecom point of view, valuable equipment needs to be protected and may require wrapping before a sandblasting or paint operation. The tank owner needs full access to ensure long-term maintenance and safety in the facility's operations. These kinds of considerations will increase a system's costs because contractors must factor cable protection, removal and reinstallation into many of their bids. Finding middle ground can be difficult. In some cases, paint repairs can only be completed during periods when water demand is low or they must wait for warmer weather. But now, both will require coordination with the telecom.

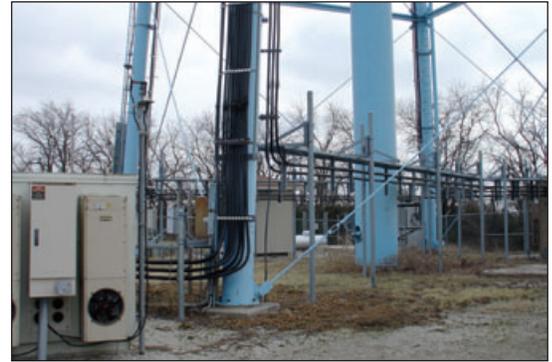
*This photo is of cable routing on the tank shown on the previous page. Cable bundles can give a vandal an easy way up.*

Cable routing is not just a problem for tank painting and recoating. Some installers route cables with a goal of making installations easier. This can restrict access to ladders, covers and

and matched in color. Cable attachments should include guards to prevent access to the tank to keep vandals at bay.

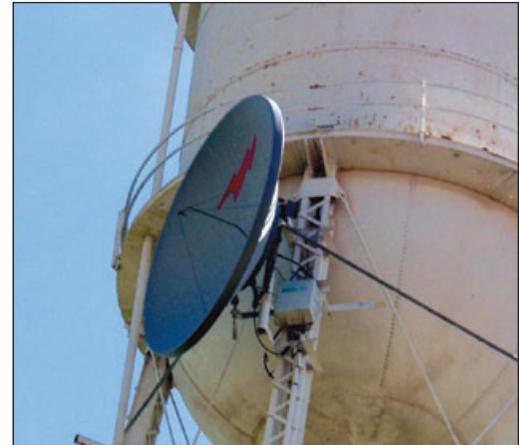
*This dish antenna mounted on a tower leg could present a structural problem if unreinforced penetrations were made. The mount location however does not present ladder or catwalk access problems.*

reinforcement of penetrations through the base of spherical and fluted column tanks. Steel plate sections in most tank roofs are thinner than the side plates; too much weight can cause them to buckle. To avoid this, the antenna frame must be properly attached and reinforced. Some installation procedures may require draining or partial draining of the tank until completion. Penetrations affecting the tank's condensate ceiling should also be evaluated for a proper seal.

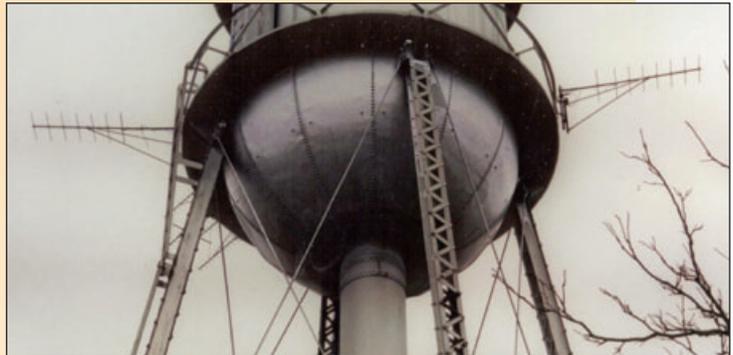
*This tank has two antennae. The left is mounted on the rail at the ladder and the other on the catwalk rail making access hazardous. At least it is symmetrical, giving it a pair of ears.*

Many times we see antennae attached directly to the tank's ladder. This is strictly taboo. For example while working on an elevated tank in Kansas several years ago, a large triangular antenna approximately 30 feet in length was attached to the tank's balcony-to-roof ladder. It completely covered the ladder. The only way to access the roof was to actually climb the antenna. These kinds of incorrect mountings cause the contractor's price to go up.
